CHAPTER 21

Conservation and Restoration of Pasir Ris Park Mangroves

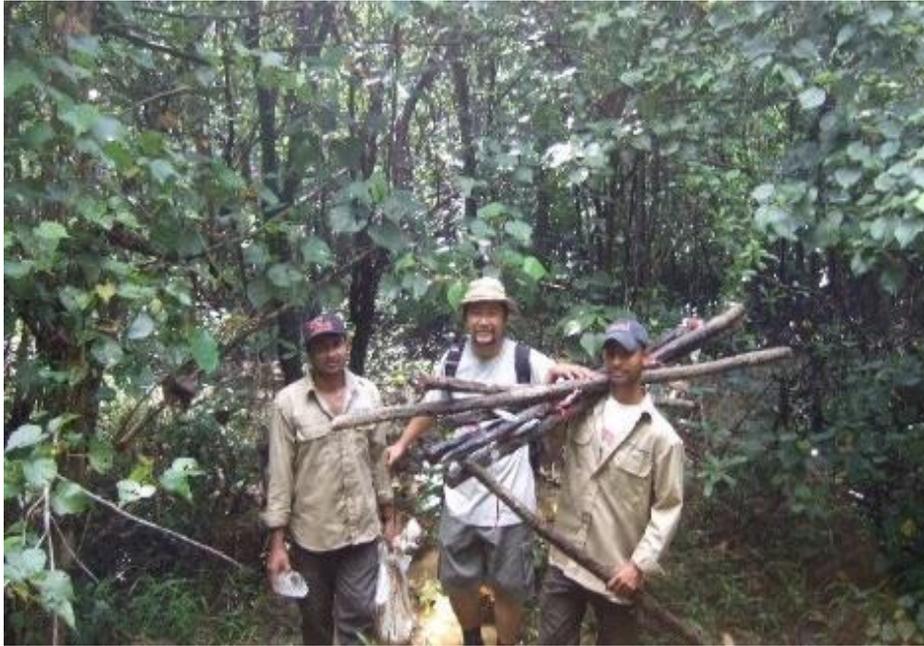
Fig. 1. Preparing for the surveying and marking of new trench lines with bakau poles at suitable sites.

To improve the hydrology at the back mangrove, soil was unearthed at several sites to investigate the feasibility of creating new trench lines to bring in water from the river to the back mangrove. The extent of tidal influence for each site was studied through observing the water trail marks on bakau (*Rhizophora* species) poles that were installed on the ground. Water trail marks on the bakau poles indicated the presence of heavy downpour or high tide. Once suitable sites for the new trenches were identified, 15 to 20 pieces of 1.5-metre-long bakau poles were used to mark out the new trench lines at each site (Fig. 1–3). Excavation was carried out to create new trench lines along the pole peg line from the river to the back mangrove. For the existing trench lines and rivulets, desilting was carried out to deepen the trenches and allow higher volume of brackish water to reach the drier area of the back mangrove.

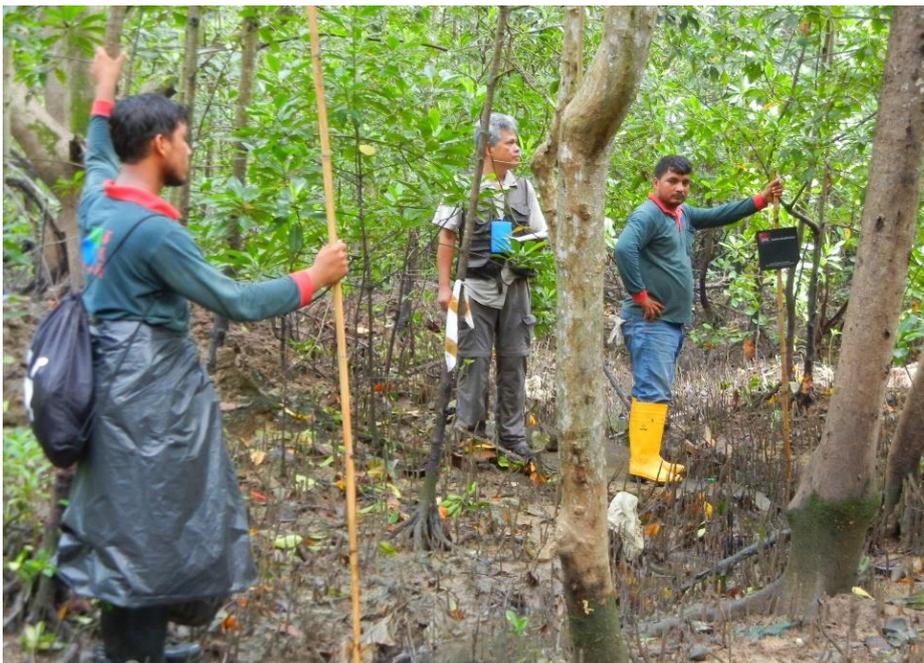
Fig. 2. Surveying and marking new trench lines at suitable sites.

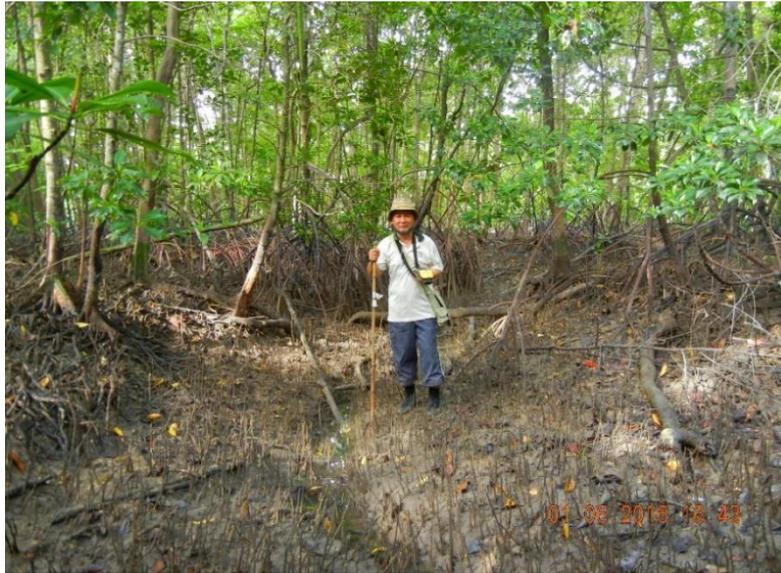
Fig. 3. Checking the new trench lines at suitable sites.

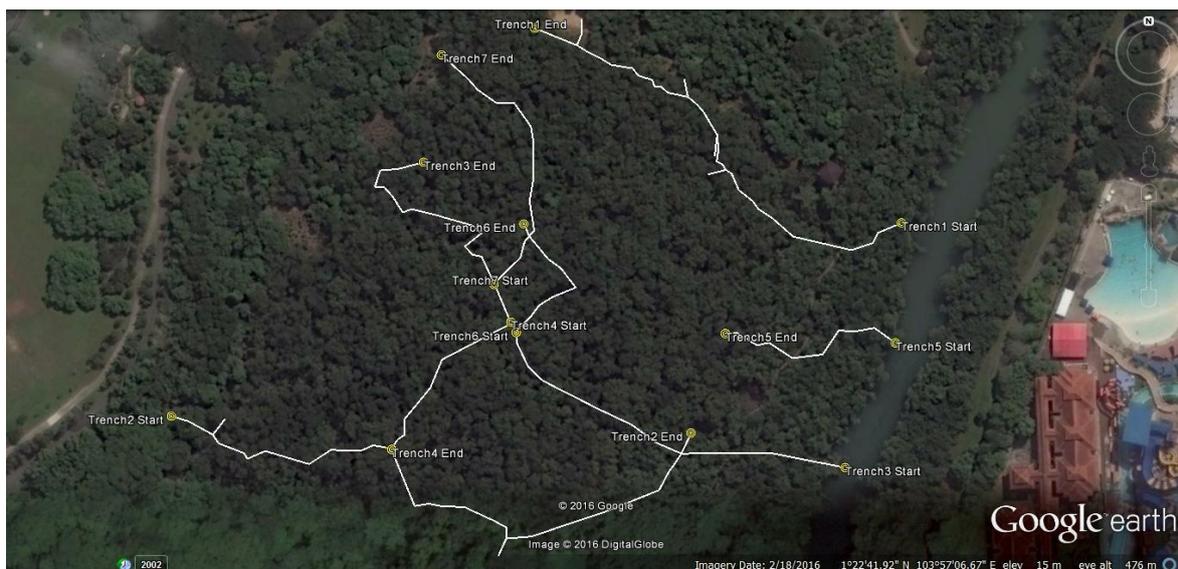
Fig. 4. Map of trench lines using GPS. (Image credit: Google Earth)

The locations of the existing and newly created trench lines were recorded using GPS. These GPS points were transferred onto Google Earth for a comprehensive overview of the network of trench lines within the mangrove (Fig. 4). GPS plotting of the trench lines was essential in the study and management of the brackish water inundation within the mangrove. This would help to project the manpower requirements and funds needed for the desilting work on a year-to-year basis.

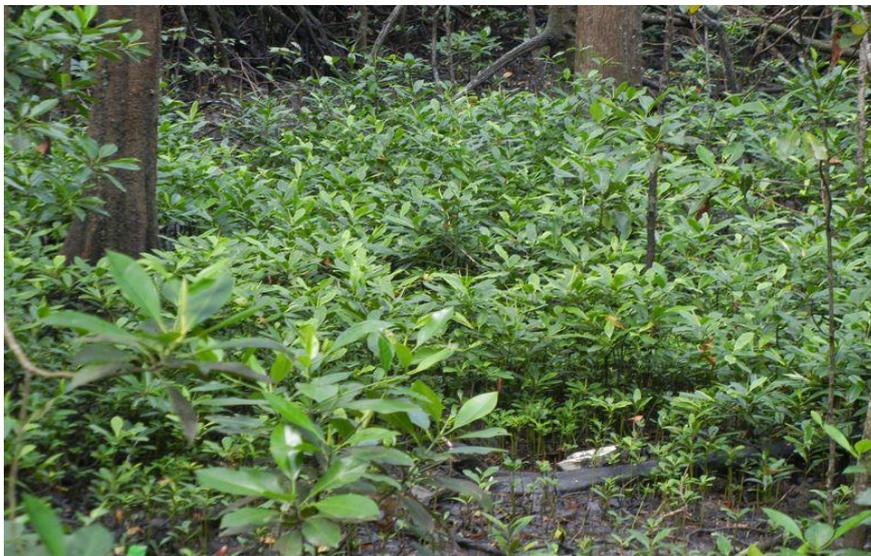
Fig. 5. Selective thinning was carried out on bigger *Bruguiera parviflora* saplings in a crowded site.

The cluttered sites were marked and the overcrowded propagules and saplings below their mother plants were identified for salvaging (Fig. 5). The plants were salvaged for the replacement planting. A corer was used for the salvaging exercises as it was more efficient compared to doing manual trenching using a *cangkul* (i.e., a hoe) (Fig. 6). More than 1,000 mangrove saplings were salvaged from the exercises (Table 1). A mangrove nursery was created for the salvaged saplings to adapt and acclimatise before being reintroduced to the new planting site (Fig. 7–8). The site of the nursery location was carefully selected based on the natural soil profile where it was naturally inundated by sea water.

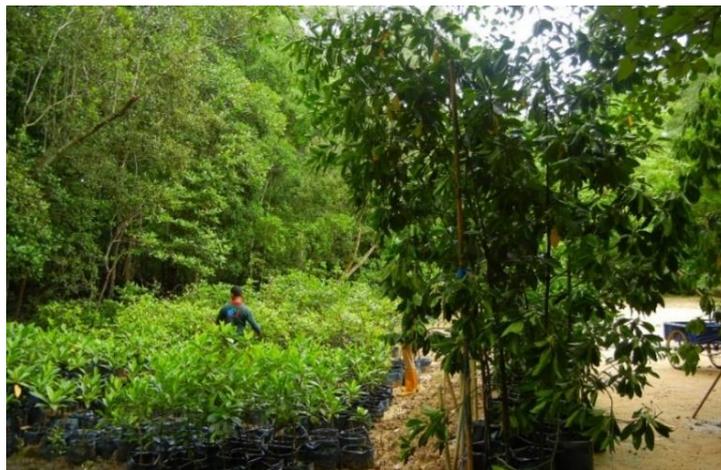
Fig. 7. Mangrove nursery in Pasir Ris Park.

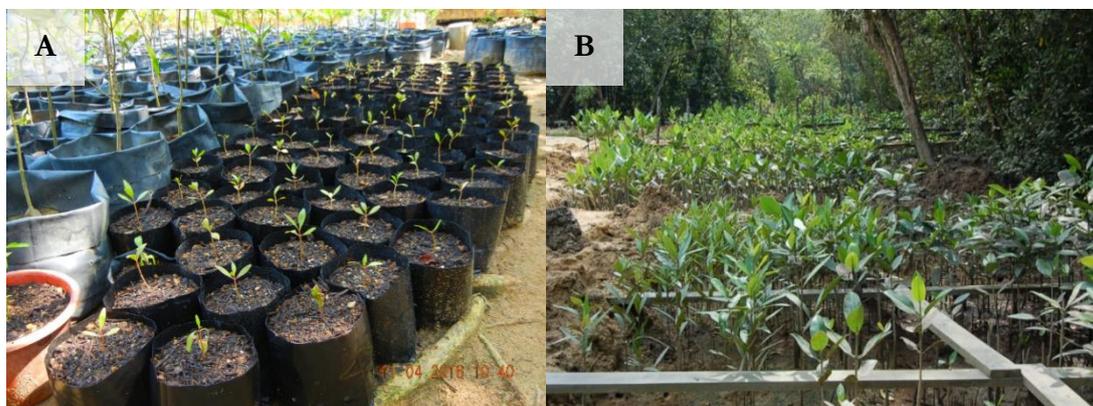
Figs. 8. (A) Mangroves growing in plastic bags; (B) Mangroves planted on the ground before being transplanted back on site.

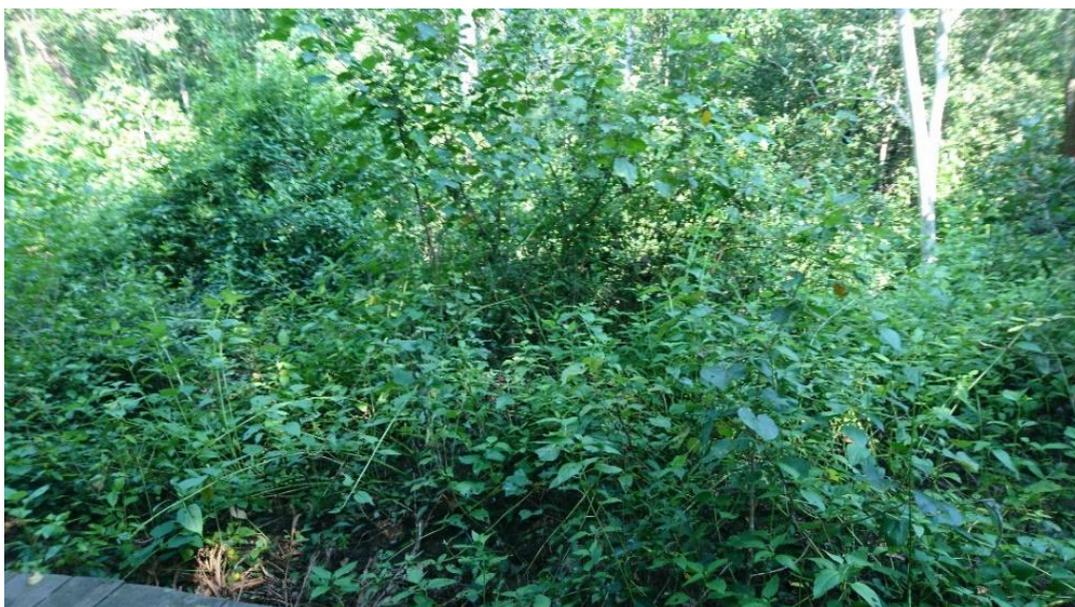
Fig. 10. Before the clearing of the terrestrial plants.

As terrestrial plants were observed to have taken over the back mangroves area, clearing of the existing vegetation was necessary to prevent competition with the slower growing mangrove plants. Over 400 square metres of terrestrial plants were removed (Fig. 10) and replaced with mangrove plant species that were salvaged (Fig. 11).

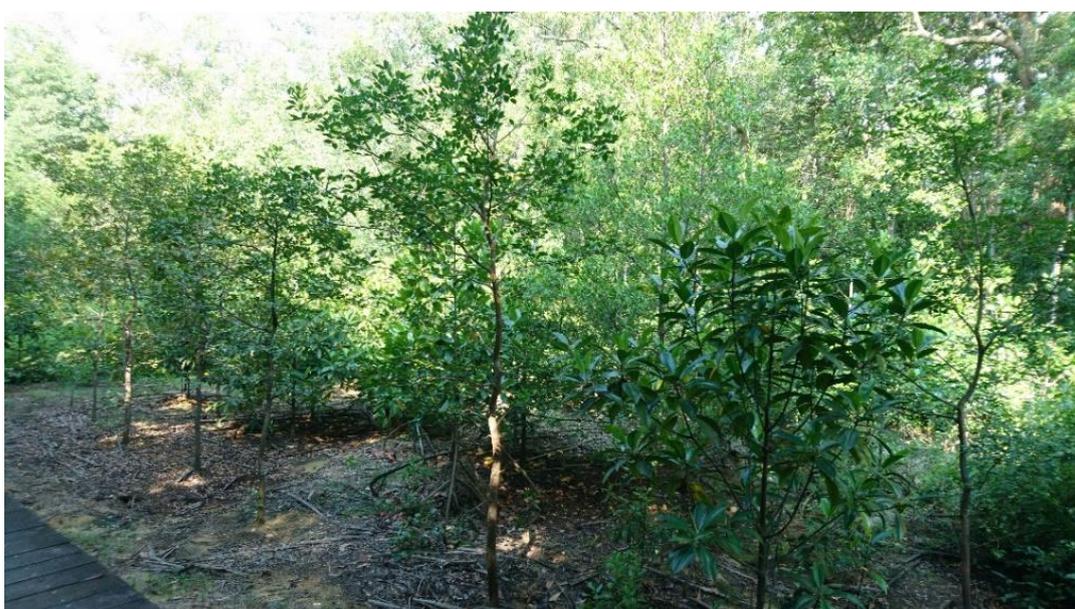
Fig. 11. Cleared area planted with salvaged and mangrove saplings grown in the nursery.

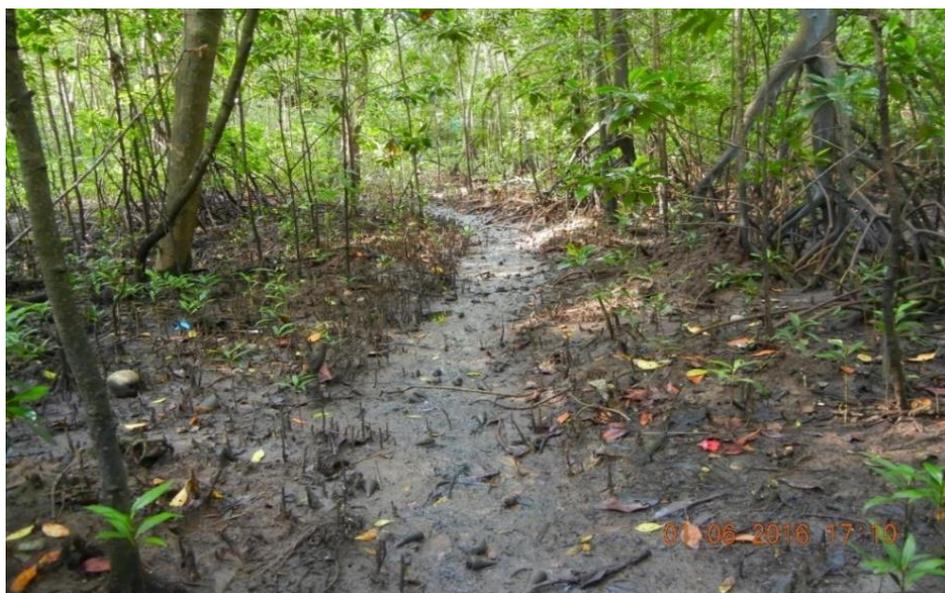
Fig. 12. Existing trench line before desilting.

After the new trenches were created, existing trenches were desilted, and the soil profile was regraded, it was observed that high volume of brackish water reached the drier area of the back mangrove (Fig. 12 & 13). This resulted in the creation of a favourable condition for mangrove species to colonise the area.

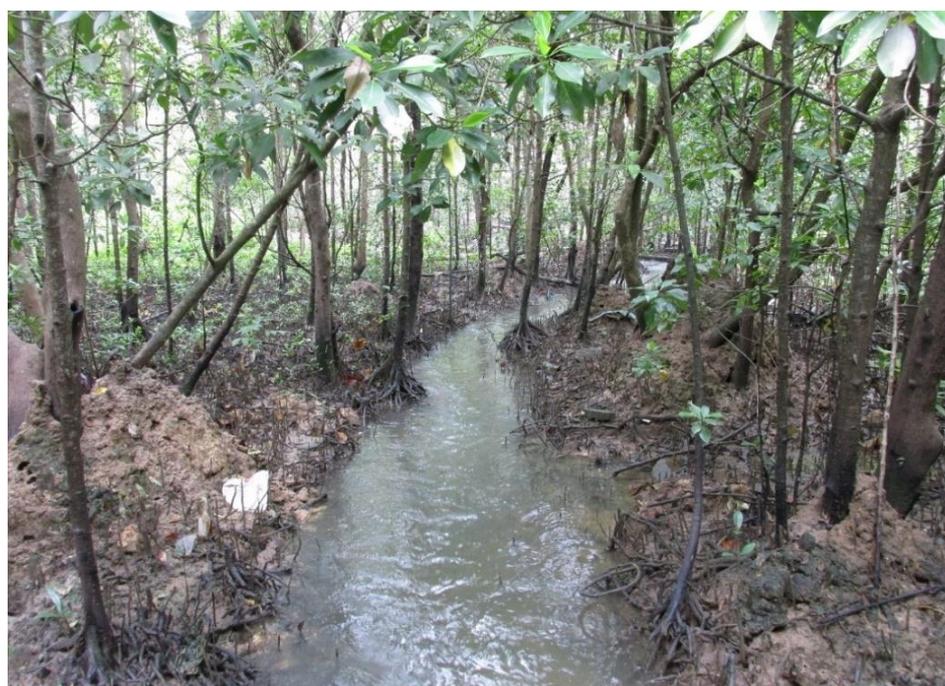
Fig. 13. Existing trench line after desilting.
