CHAPTER 12

Lessons Learnt from Habitat Restoration at Marsiling Park

Eslindah Ismail & Cai Yixiong

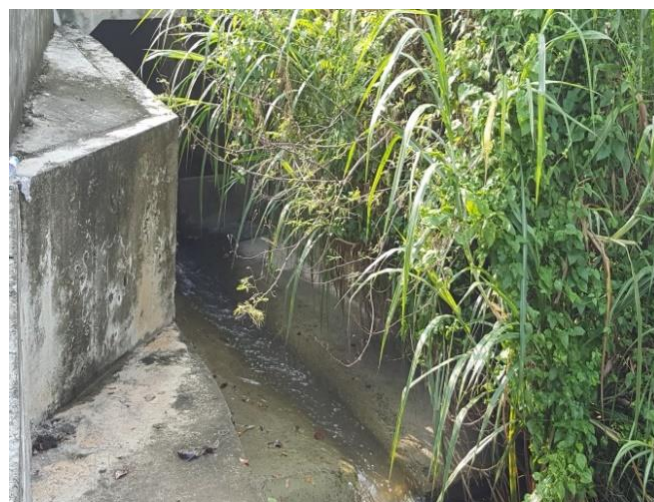
Fig. 3. Freshwater inputs entering the mangrove forest via the bund for overflow from the pond and lined drains.

The mangrove forest is a highly degraded remnant back mangrove (National Parks Board, 2006), with freshwater inputs entering it via the bund for overflow from the PUB storm water pond and lined drains (Fig. 2 & 3). It also includes the uppermost end of the upstream section of Sungei Mandai Kechil, thus it is inundated during high tide. The lower course reaches to Sungei Mandai Kechil and is surrounded by Sungei Mandai Mangrove. The substrate of the site is mainly composed of siliceous sand. Surrounding the back mangrove is grassland, secondary forest, and typical trees in the park (Fig. 4). The section that connects Marsiling Park and Sungei Mandai Mangrove has been turned into a concrete channel as a result of urbanisation (Fig. 5).

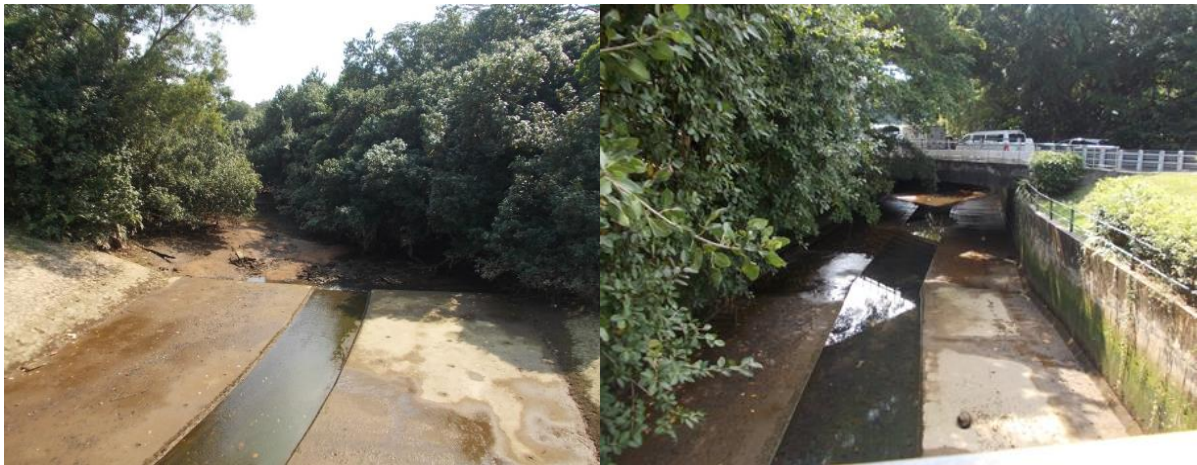
Figs. 5. Part of the Sungei Mandai mangrove that had been concretised into drains.

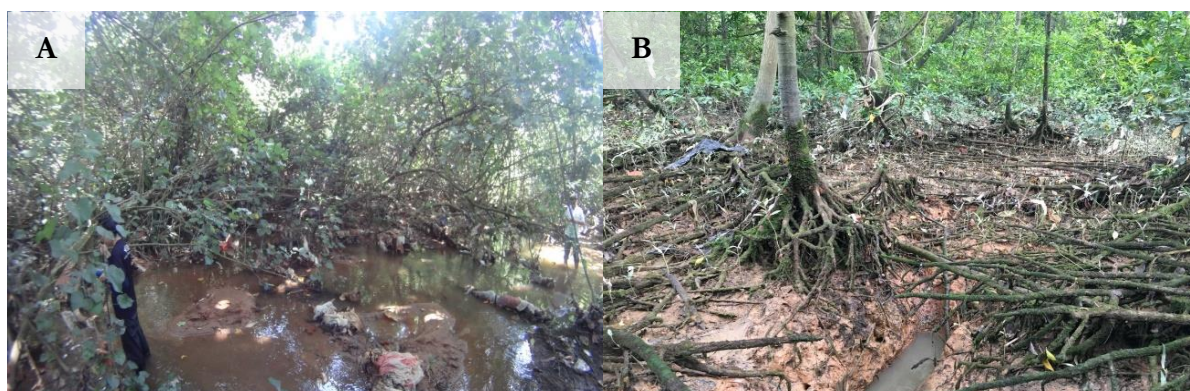
Figs. 6. (A) Flotsam in the mangrove area; (B) Soil erosion observed at the mangrove patch next to the PUB Storm Water Pond. (Photo credit: Cai Yixiong)

The mangrove forest faced threats such as the massive inflow of freshwater from the drains and storm water pond that was filled with flotsam during heavy rainfall (Fig. 6A), human disturbance like littering and poaching, and the canalisation of Sungei Mandai Kechil into concrete drains which reduced the inundation by seawater during high tides and thus altered the site's hydrology. This also caused the mangrove habitat to further degrade; the habitat could even disappear eventually in the long term due to the lack of saline water input, which lowered the salinity level of the water in the mangrove site, and could result in the loss of some key species of the flora and fauna. In addition, soil erosion and siltation had slowly built up along the mangrove course due to the changes in hydrology at site (Fig. 6B).

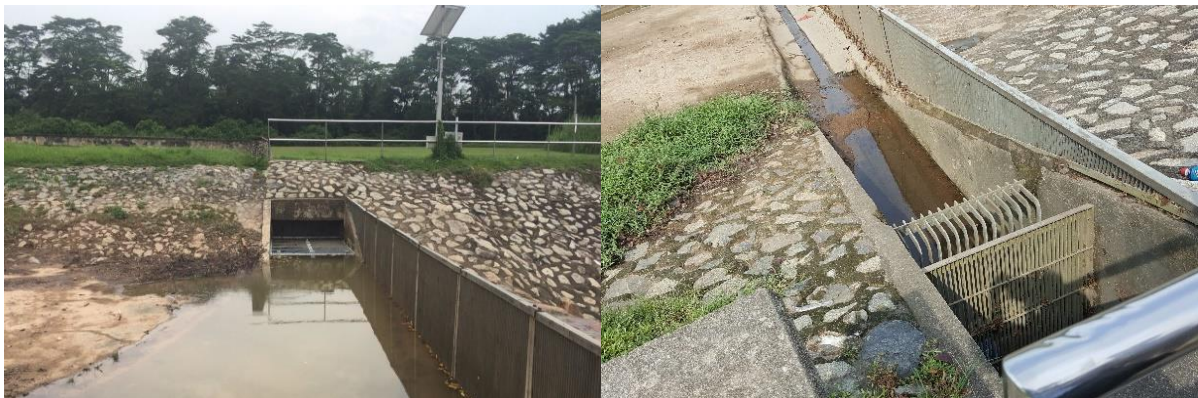
Figs. 8. A filtration system at the start of drain channels into the mangrove area.

In addition, a biweekly maintenance cleansing regime to remove the flotsam, trash, and litter from the stream was executed to ensure that the stream was minimally impacted in the long run. A filtration system was installed at the start of open concrete drain outlet to limit the amount of rubbish getting into the stream (Fig. 8). Public Utilities Board (PUB) also stepped up its cleansing regime in removing the flotsam from the storm water ponds next to the mangrove patch especially during the monsoon season.

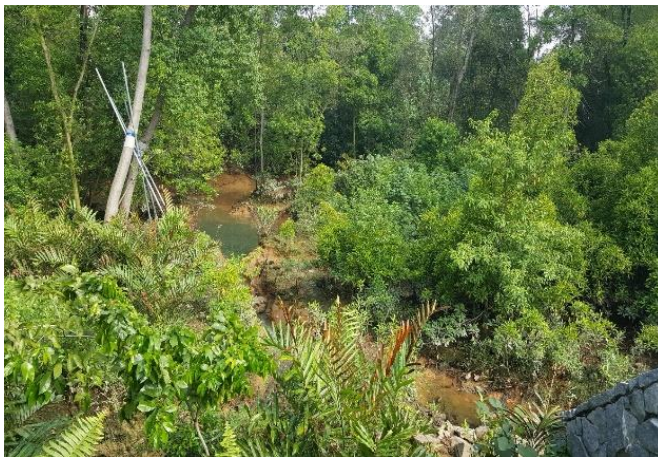
Fig. 9. Back mangrove saplings along the creek.

The common and easy-thriving mangrove plants had been reintroduced mainly in the habitat enhancement of the mangrove site. The planting of 10% dominant species, namely *Avicennia* spp., *Sonneratia* spp., *Rhizophora* spp., and *Bruguiera* spp., would facilitate the restoration of the mangrove habitat (Fig. 9). The heavy Sea Hibiscus vegetation along the mangrove creek next to the park side had also been removed and those located opposite the park had been pruned to make head room for the new mangrove saplings to nurture and become established at site. Fallen branches were regularly removed so that these saplings could thrive in the long run.

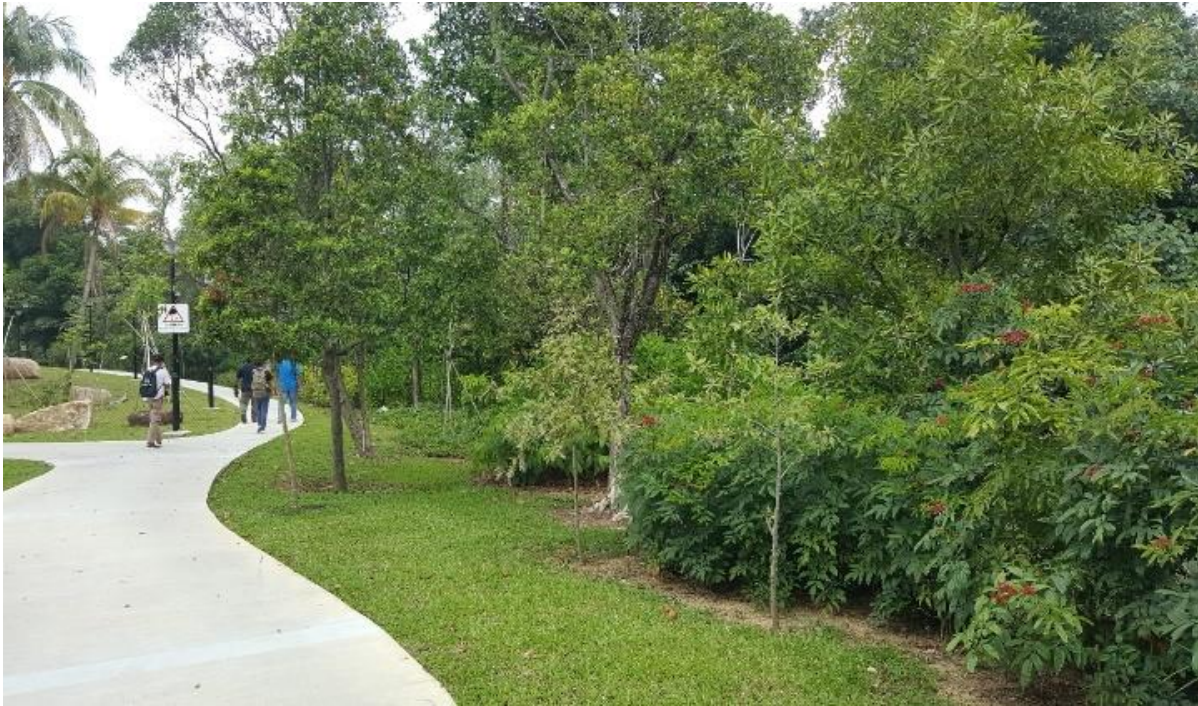
Fig. 10. Plant species adapted to the edges of the creek.

Furthermore, the back mangrove area had been enhanced with plant species that could do well in a low density of brackish water. These plants include Cannonball Mangrove (*Xylocarpus granatum*), Katong Laut (*Cynometra ramiflora*), Mangrove Palm (*Nypba fruticans*), False Lime (*Suregada multiflora*), and White Samet (*Melaleuca cajaputi*). Species such as *Neolitsea zelaynica*, Penaga Laut (*Calophyllum inophyllum*), Chengal Pasir (*Hopea odorata*), and Thick-Leafed Jambu (*Syzygium pachyphyllum*) that adapted to the landward edge of the mangroves were also planted along the periphery to create a natural buffer between the mangrove forest and the park (Fig. 10).
