CHAPTER 15

Habitat Enhancement for Slope Stabilisation at Kent Ridge Park

Soh Ze Bin, Mohammad Roslee Ali & Holly Siow

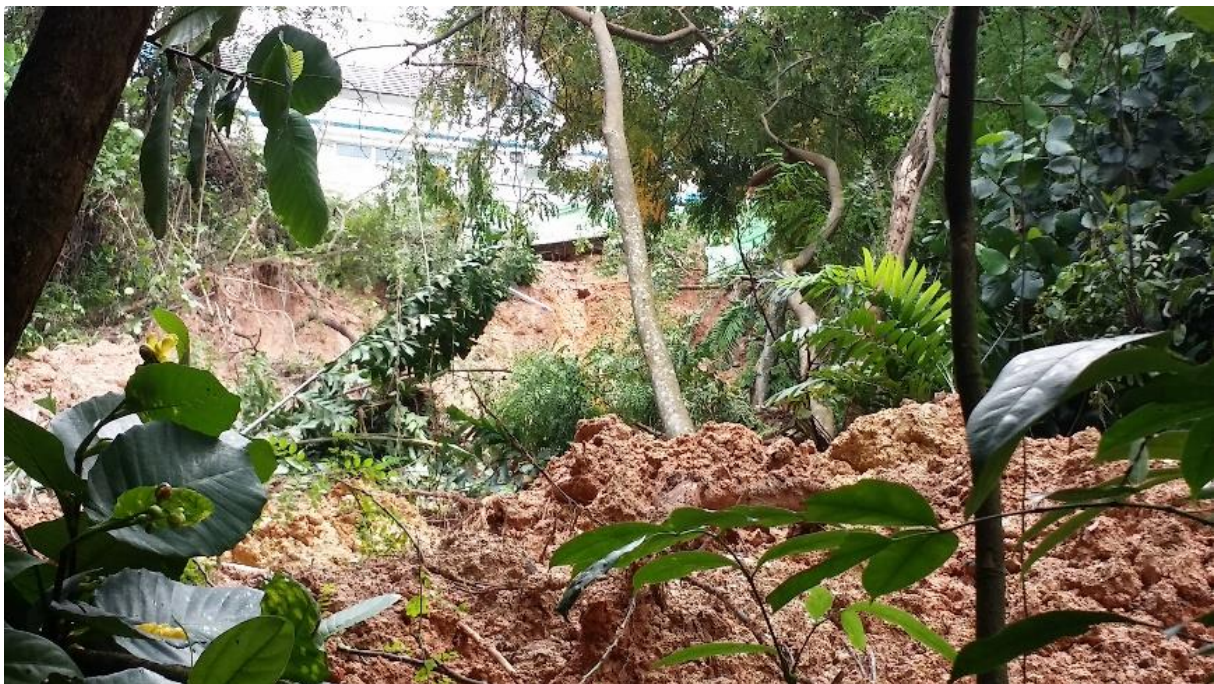
Fig. 1. Slope failure at Kent Ridge Park, Mountain Bike Trail in December 2015.

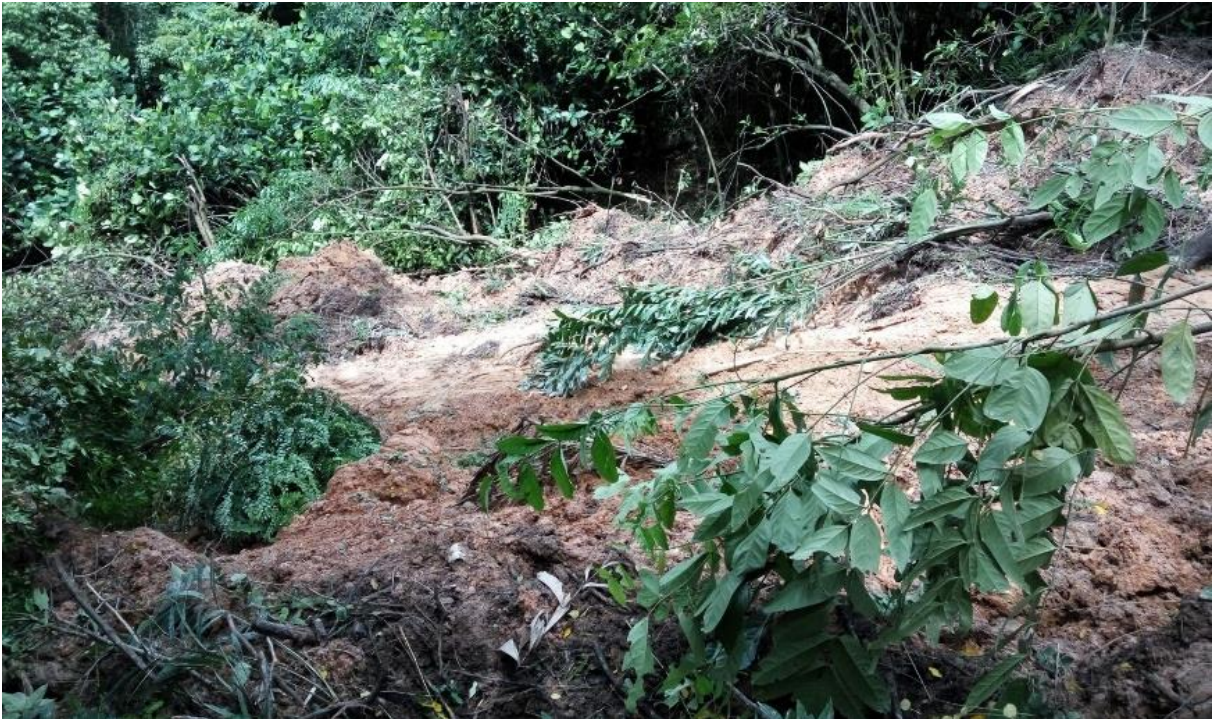
In early December 2015, a section of a southward facing slope within the Kent Ridge Park Mountain Bike Trail failed and a landslide resulted (Fig. 1). The affected area covered a total area of approximately 0.3 hectares (3,000 square metres) (Fig. 2), measuring about 100 metres long and 30 metres wide with an elevation difference of about 30 metres. The area had a dense vegetation of predominantly secondary forest species such as *Adinandra dumosa*, *Cyrtophyllum fragrans*, *Dillenia suffruticosa*, and *Macaranga heynei*.

Fig. 2. Approximately 3,000 square metres of area was affected.

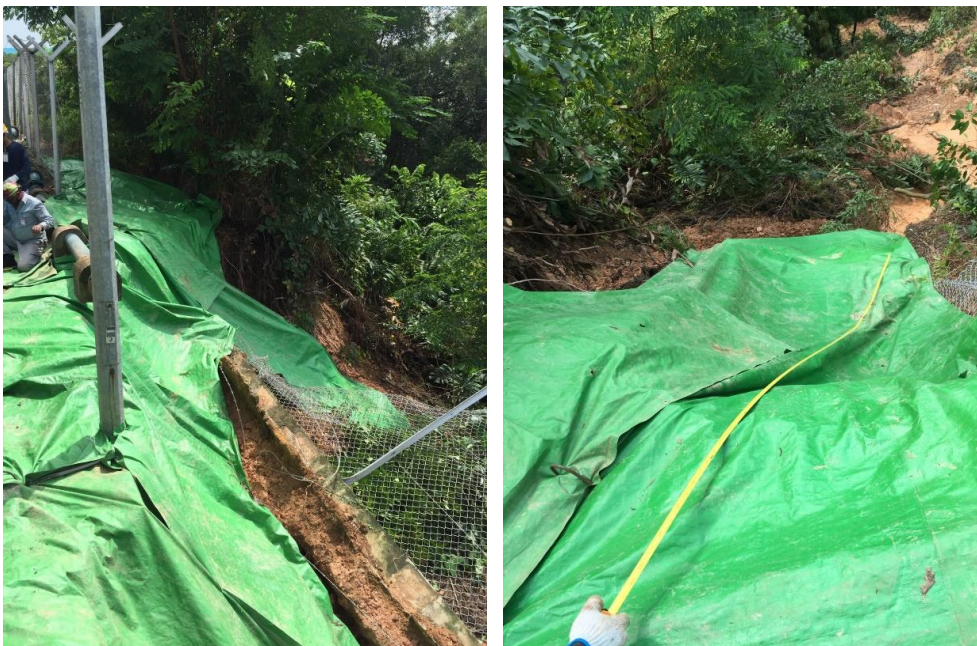
Waterproof canvas sheets were laid over the bare exposed areas to protect them from further water erosion and to minimise water seepage into the ground (Fig. 3).

Figs. 3. Large canvas sheets were laid over to prevent the saturation of soil, which might lead to further slope failure.

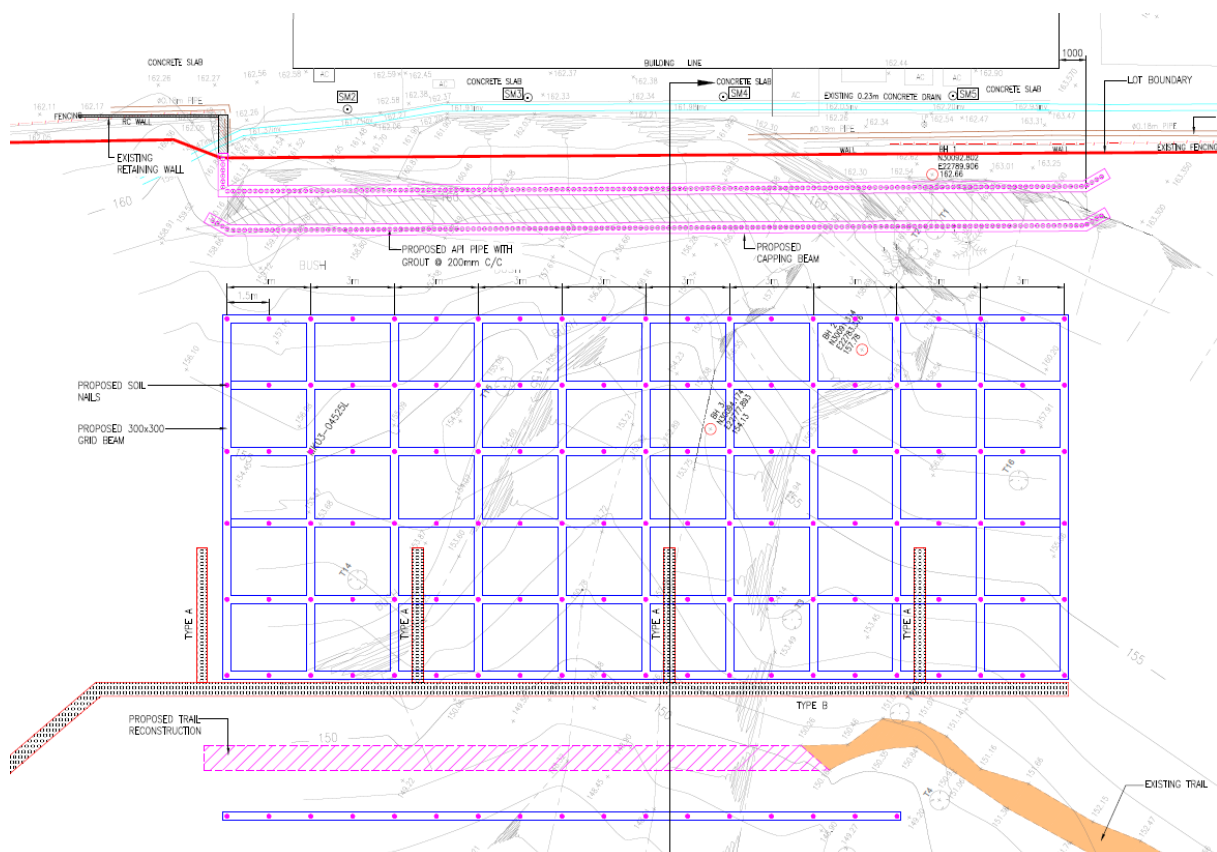
After analysing the results, the final stabilisation method chosen for the area was the soil nail with grid beam method (Fig. 4). Soil nails each measuring up to 12 metres in length were inserted perpendicularly into the ground. Subsequently, concrete grid beams were cast around each of the nail in the shape of a square which were filled up by soil and turf. In addition, the previous bike trail had to be reinstated. Each of the grid beam measured around 3 metres by 3 metres to provide sufficient planting space for small trees, where possible, and shrubs. The depth of soil added was roughly 0.3 metre for the grid beam section.

Fig. 4. Grid beams layout plan.

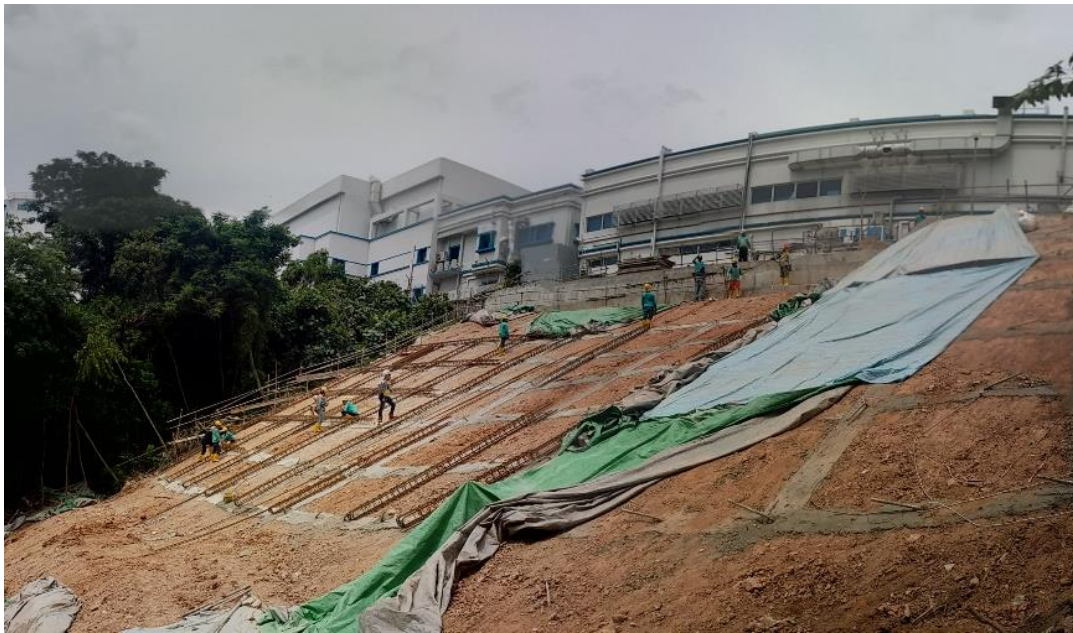
Fig. 5. Construction of grid beams in October 2016.

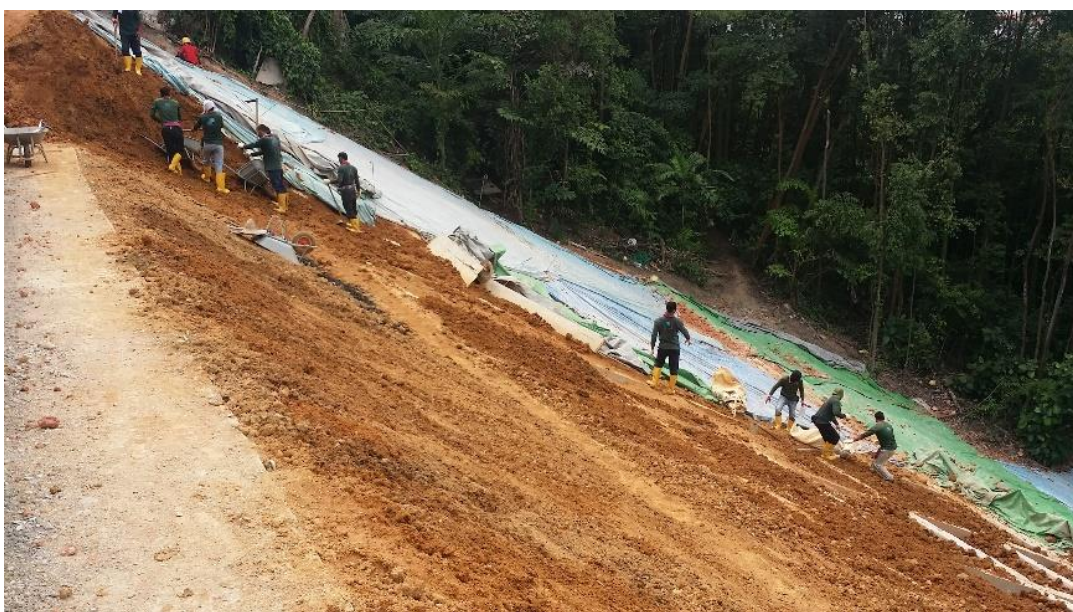
Fig. 6. Backfilling of soil in January 2017.

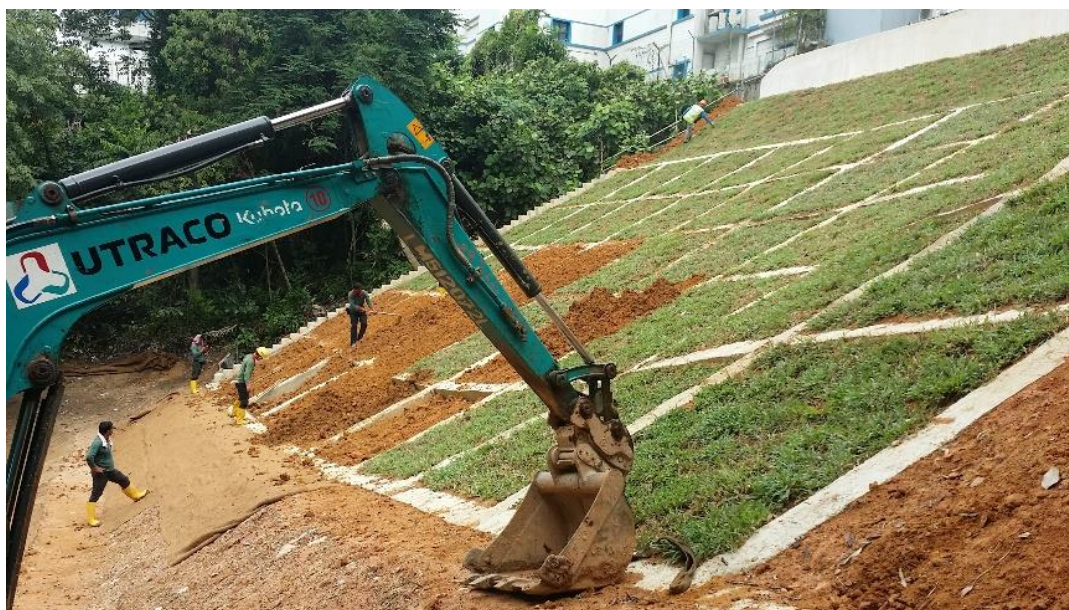
Fig. 7. Planting of turf at end January 2017.

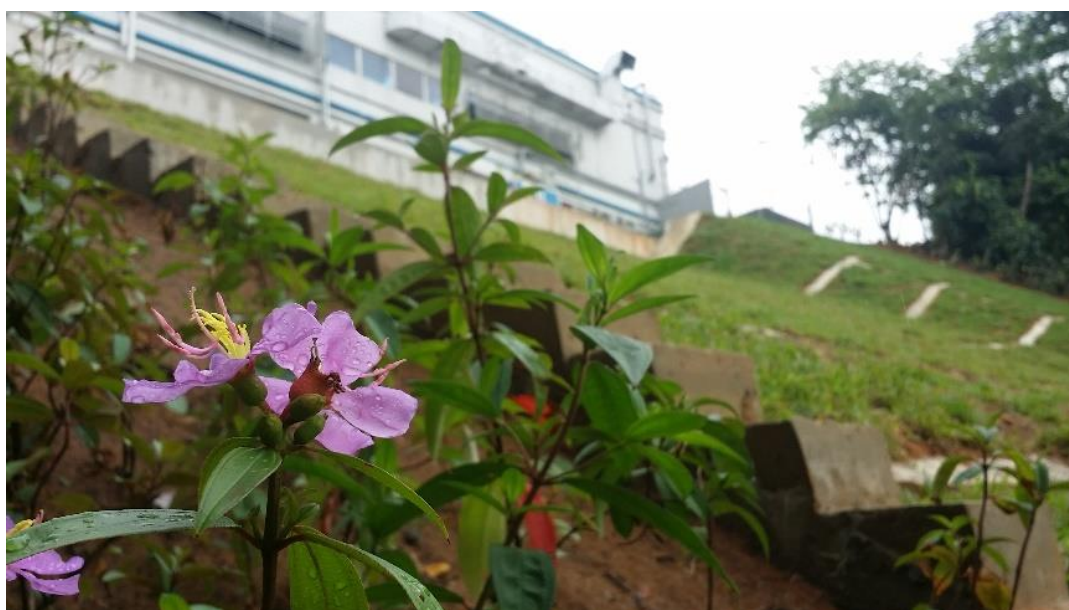
Fig. 8. Planting of native shrubs (*Melastoma malabathricum*) on Area 1 in February 2017.

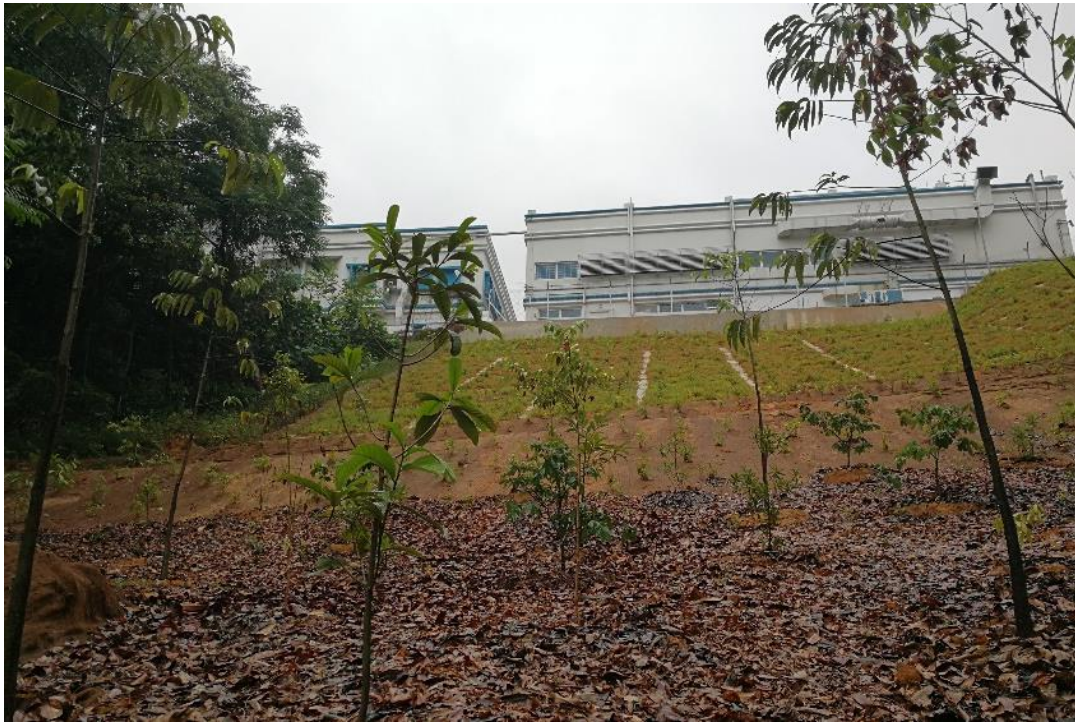
Fig. 9. Differentiation of planting at Area 1 (shrubs) and 2 (trees and larger shrubs) in February 2017.

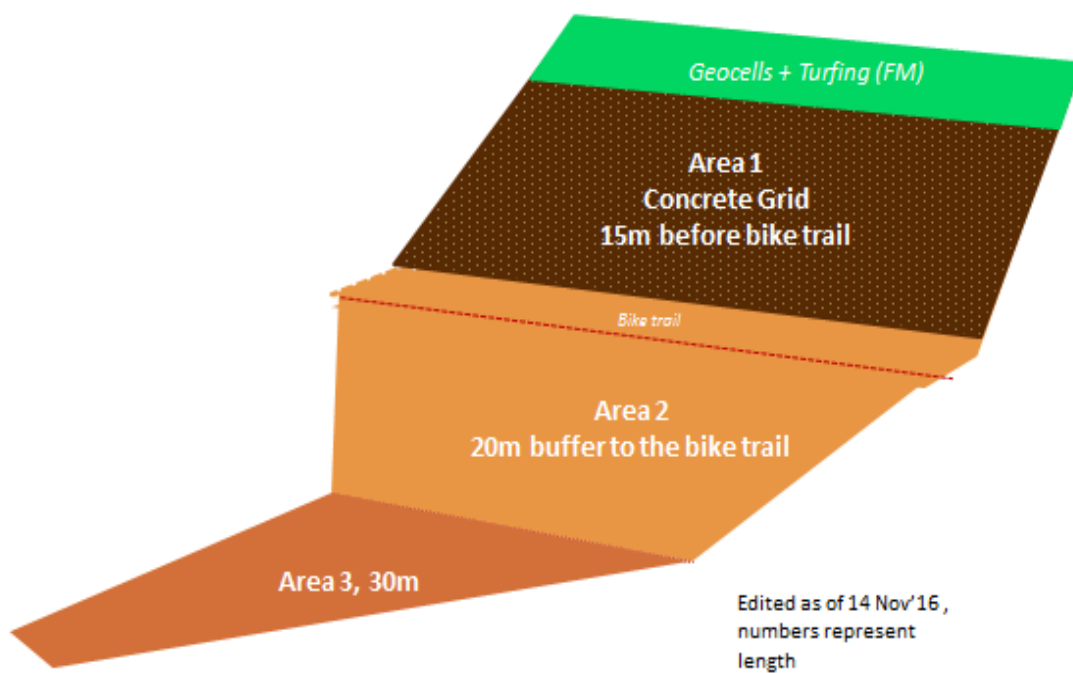
Fig. 10. The 3 distinct slope areas, with reference to the indicative mountain bike trail track.

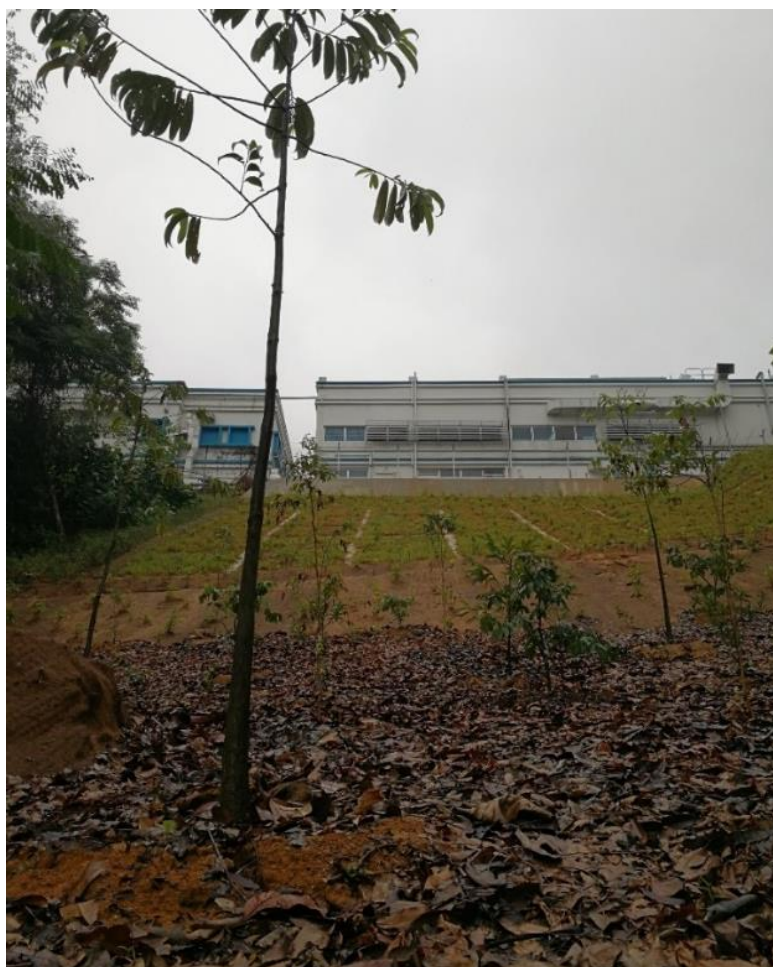
During the survey of January 2019, many of the original species that were planted survived although some did not establish well (Fig. 12). This could be due to the soil conditions where they were planted in. The soil at Kent Ridge Park was tested and found to be acidic with a pH level of 5 to 5.5. The lack of substantial organic matter on the ground surface, as only young trees were planted, was not enough to improve the soil condition and pH level.

Fig. 12. Most of the tree saplings survived, as seen during a visit to the site in February 2017.

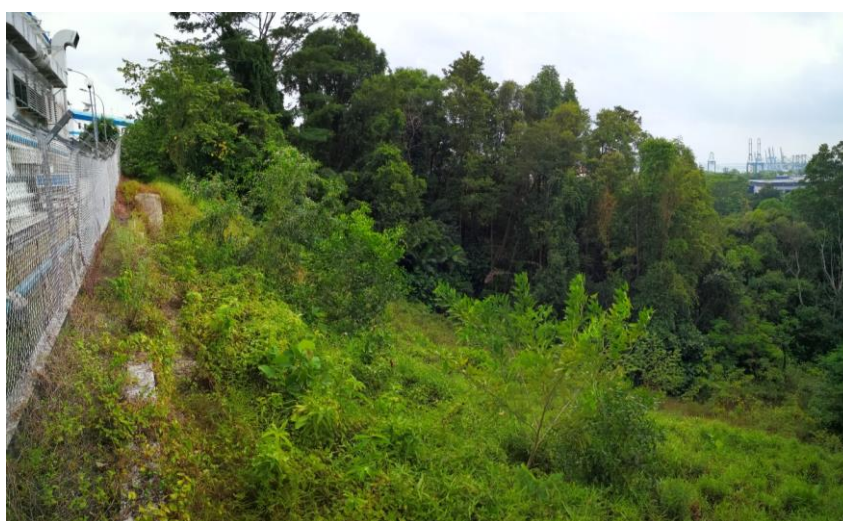
Figures 13 and 14 show how habitat restoration and enhancement works can transform a slope failure and degraded site to a stable slope with enriched niches for flora and fauna, leveraging on nature-based solutions. This project demonstrates that nurturing a suitable environment would lead to self-recruitment of flora and fauna, hence, leading to a long-term regeneration of natural ecosystems. Monitoring the site would enable NParks to learn how ecological succession occurs in parks that are near highly urbanised areas and how the state of a park can become closer to that of more pristine natural ecosystems.

Fig. 13. View from top (towards the east) photographed in 2019.

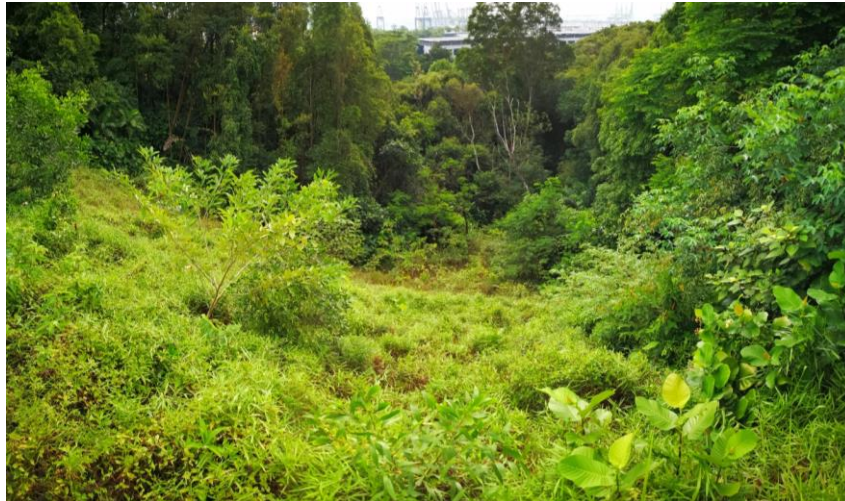
Fig. 14. View from top (towards the south) photographed in 2019.

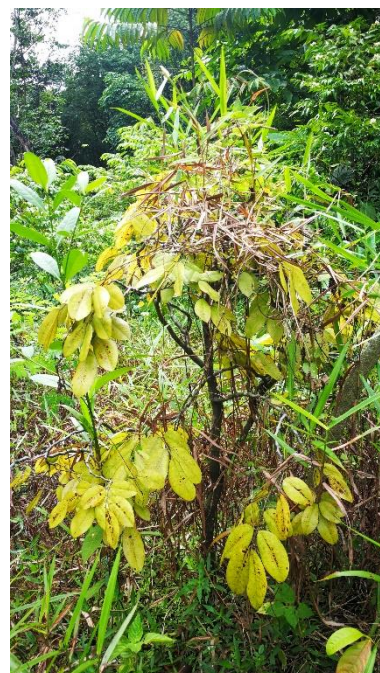
Sindora wallichii

Some of the trees such as *Horsfieldia irya*, were observed to be doing better than others such as *Sindora wallichii*, where they were showing signs of yellowing in their leaves which could be caused by a variety of health problems such as nutrient deficiency in the soil and lack of water (partially due to the drier weather conditions in January 2019).
