## Research Technical Note Urban Ecology Series

04-2013

## Maintenance Requirements for Bioretention Systems in the Tropics

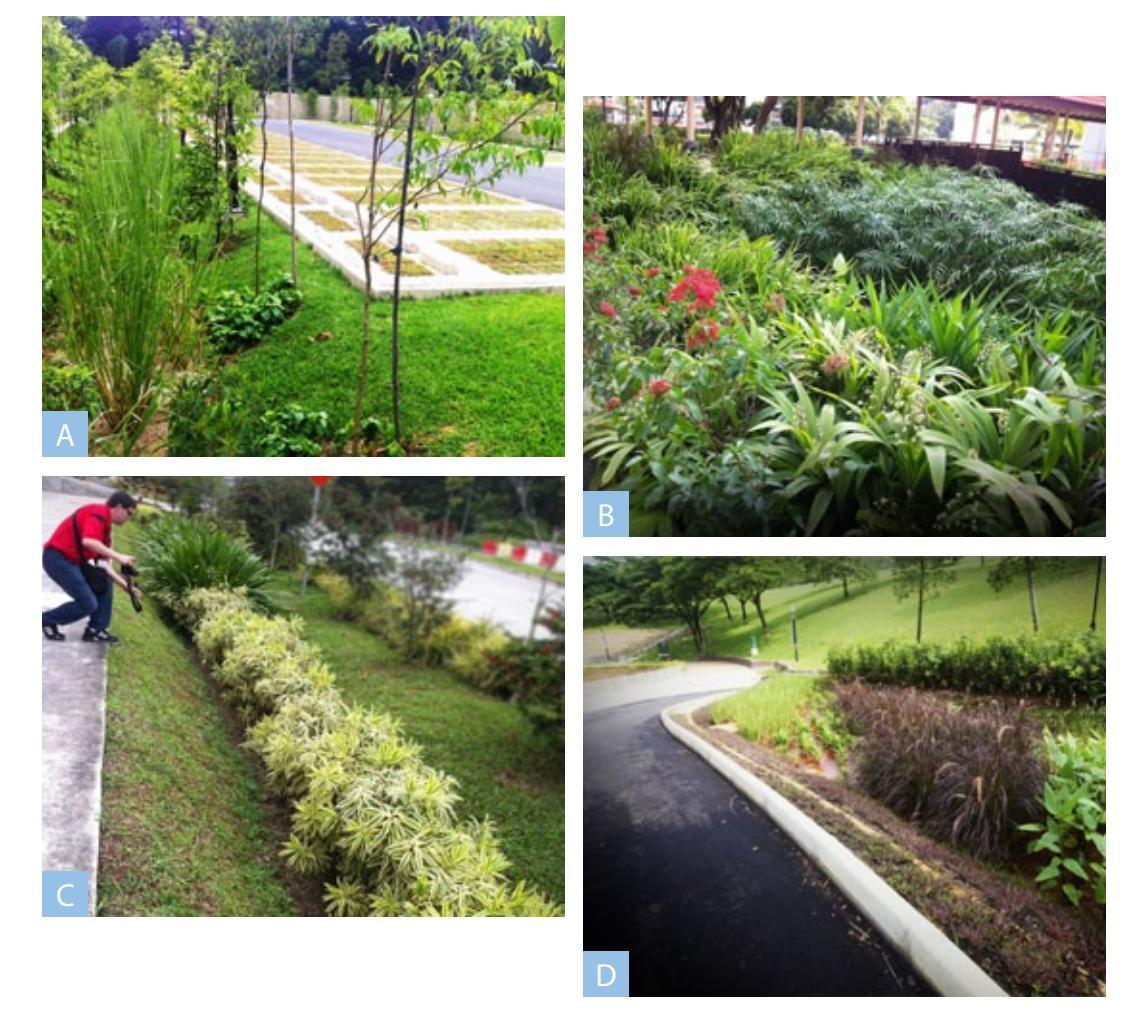
Fig 1. Various bioretention systems located in (A) a car park, (B) a residential community area, (C) a streetscape, and (D) Admiralty Park.

Bioretention systems, also termed biofiltration and rain gardens, are becoming more popular in Singapore. Bioretention installations are almost always expected to look manicured, as they are often installed at publicly visible locations. Examples of bioretention systems in Singapore are shown in Fig 1.

Much of the maintenance requirements of bioretention systems are aesthetic related. Considering that they are often used in lieu of standard medians in car parks (Fig 1A) or in place other landscape features, the maintenance cost per hectare, though higher than wet ponds and constructed stormwater wetlands, are in fact similar to standard landscape maintenance costs. The maintenance regime though primarily aesthetic, also improves safety, hydrologic and water quality performance.

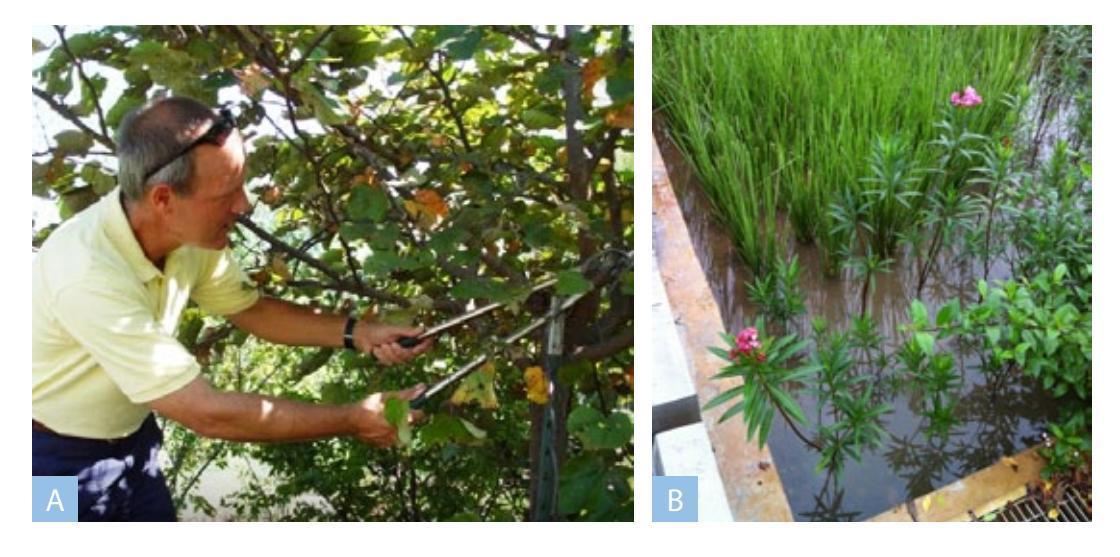
**Fig 2.** (A) Pruning for Bioretention systems should carried out annually to biannually, (B) bioretention systems are designed to be ponded for just 1 - 2 hours after each rain event.

Like any landscape features, bioretention systems require regular maintenance. The tasks include pruning and initial mulching (Fig 2). Some bioretention systems are installed with turfgrass and these require mowing. Because vegetation is essential to the aesthetic appeal of bioretention systems, it needs to be established as quickly as possible. Fortunately, due to Singapore's optimal climate for plant growth warm - temperatures and ample precipitation, vegetation is expected to establish very quickly.

Typically, bioretention systems in Singapore are designed to be inundated for only 1 - 2 hours. Water in the bioretention systems will be discharged completely from the systems 6 hours after a rain event. If surface water continues to be present 1 day after rainfall, one of the likely causes could be an improper of filter media has been used. When an inappropriate filter media is installed (e.g. it contains high levels of fine silt and clay materials) it may result in compaction or even structural collapse. This leads to a substantial reduction in the soil infiltrability (hydraulic conductivity). Hence, water will not infiltrate through the media but pond on the surface instead. If this happens, in-situ soil hydraulic conductivity test needs to be performed.

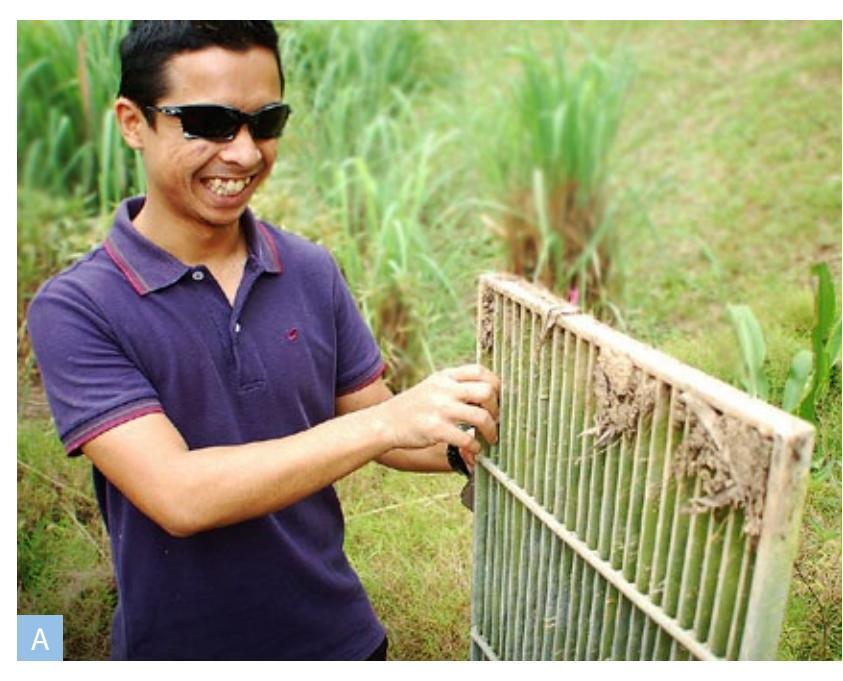
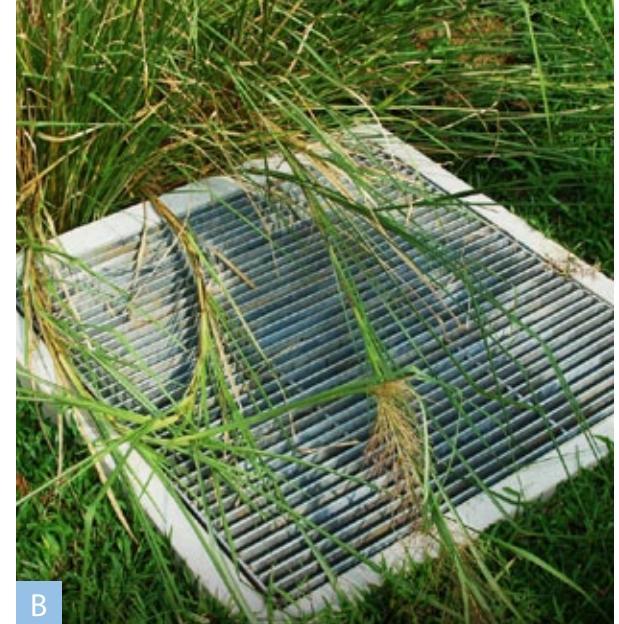
Fig 3. (A) The debris accumulated needs to be removed. (B) This outlet grate is not clogged, but vegetation and rubbish may continue to collect on the grate, causing water to spill into surroundings.

Bioretention outlets are prone to clogging, but monthly inspection and maintenance will help address this concern. It is imperative that outlets are checked monthly to ensure that they are free of litter and debris (Fig 3). This is particularly important if a grate is used on the highflow bypass structure. Nearly every bioretention system has an overflow, so if the outlets cannot be located, the engineering design plans have to be checked. A summary table of the most likely maintenance needs and their triggers is found in Table 1.

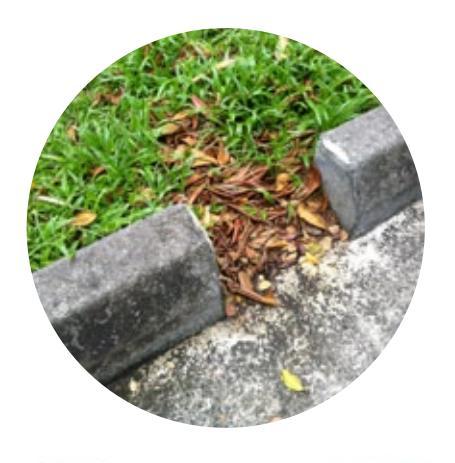
70mm set down Machellan and a start

road edge

**Fig 4.** This photo shows leaf litter accumulating at water entry point where the grass is the same level as the road. To avoid this accumulation, a tapered flush kerb must be used that sets the top of the vegetation 70mm (as shown in the cross section), which requires the top of the ground surface (before turf is placed) to be approximately 100mm below the road surface.
