## CHAPTER 20

## Mangrove Restoration in Pulau Ubin

Robert Teo

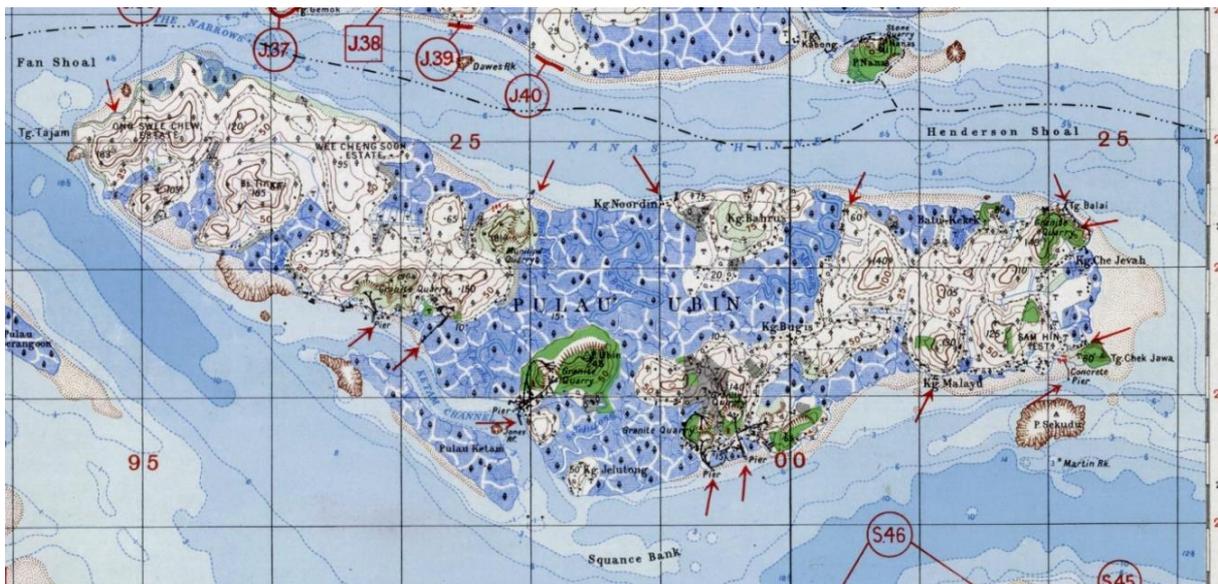
Fig. 1. Topographical map of Pulau Ubin, 1939. (Image credit: Maps MOD GSGS 3772 Sheet 3 L/12b Second Edition, The British Library)

An early topographical map produced by the British colonial government in 1939 showed that Pulau Ubin used to be a cluster of five land masses separated by tidal mangrove rivers (Fig. 1) and mangrove and associated intertidal swamp constituted about 40% of the vegetation cover. Much of the original mangrove vegetation was cleared with the introduction of prawn farming and the five disparate land bodies were eventually connected into the single island of today through the infilling of intertidal areas and the building of bunds and bridges. By the 1960s, about 50% of the original mangrove and intertidal swamp habitats had already been converted to prawn farms or land.

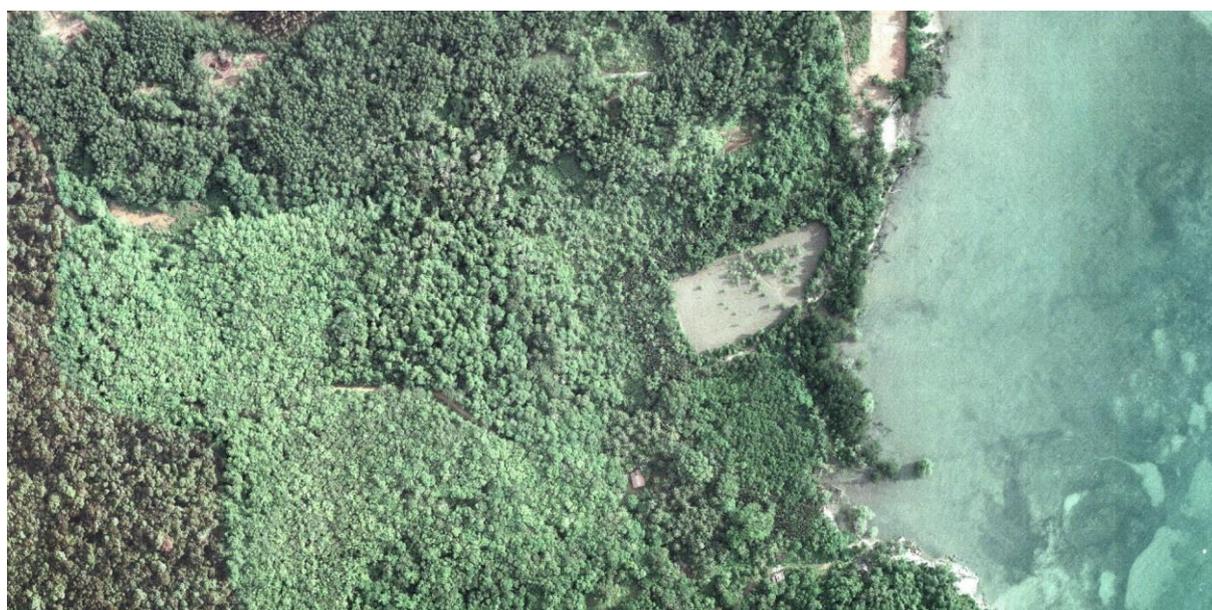
Fig. 2. Aerial photograph showing mangrove area at Chek Jawa Wetlands in 2001.

The project at Chek Jawa Wetlands centred on an abandoned prawn farming pond covering about 2 hectares, within a 6-hectare mangrove forest area (Fig. 2). Based on aerial photographs from the Ministry of Defence, the pond was in operation from at least 1969 to 1999. The prawn farming utilised local traditional farming methods, comprising a pond surrounded by mud bunds, with a sluice gate to control tidal inundation. The bunds were likely formed from mud excavated to create the pond and consisted of fine clay with remnants of mangrove mollusc shells.

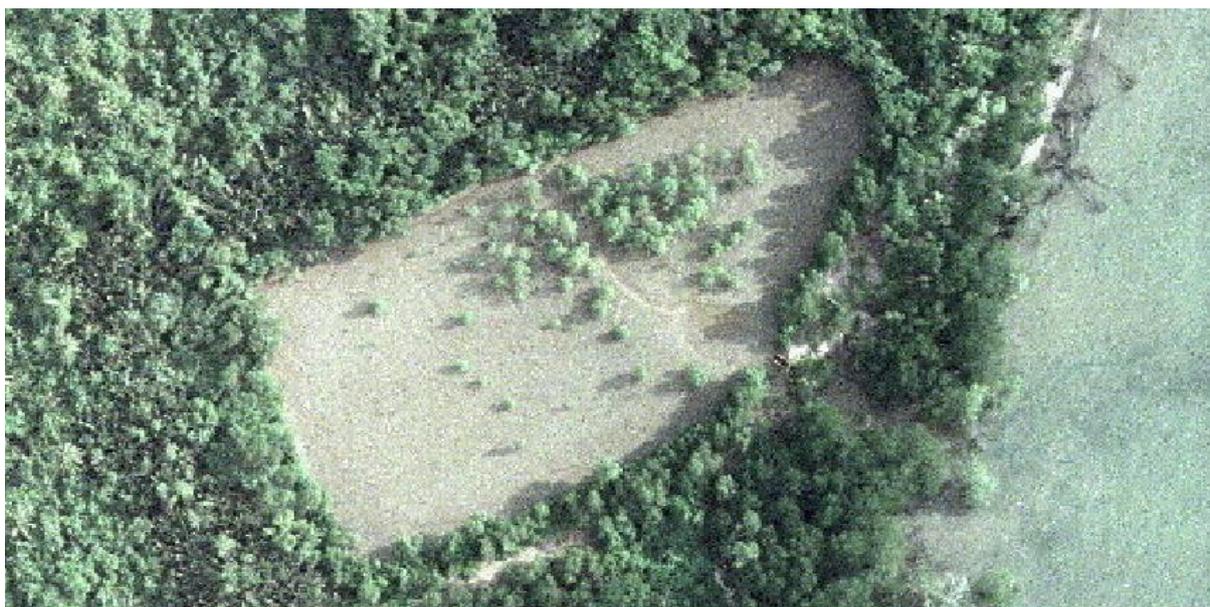
Fig. 3. Aerial photograph showing close-up of abandoned pond in 2001.

With the cessation of prawn farming operations, mangroves started to colonise naturally in shallower areas of the pond by 2001 (Fig. 3). A project to expedite the natural colonisation of mangroves commenced in 2005. Alien invasive plant species (e.g., *Acacia auriculiformis* and *Falcataria falcata*) which had established around the abandoned pond were removed, and the bunds were levelled down (Fig. 4 & 5) to allow inundation during high tides and exposure as the tides recede. The excavated materials were used to fill in the sides of the pond to raise the bottom of the pond in those areas. The restoration efforts facilitated the natural dispersal and establishment of mangrove seedlings in the relevelled areas – along the former bunds and the sides of the pond.

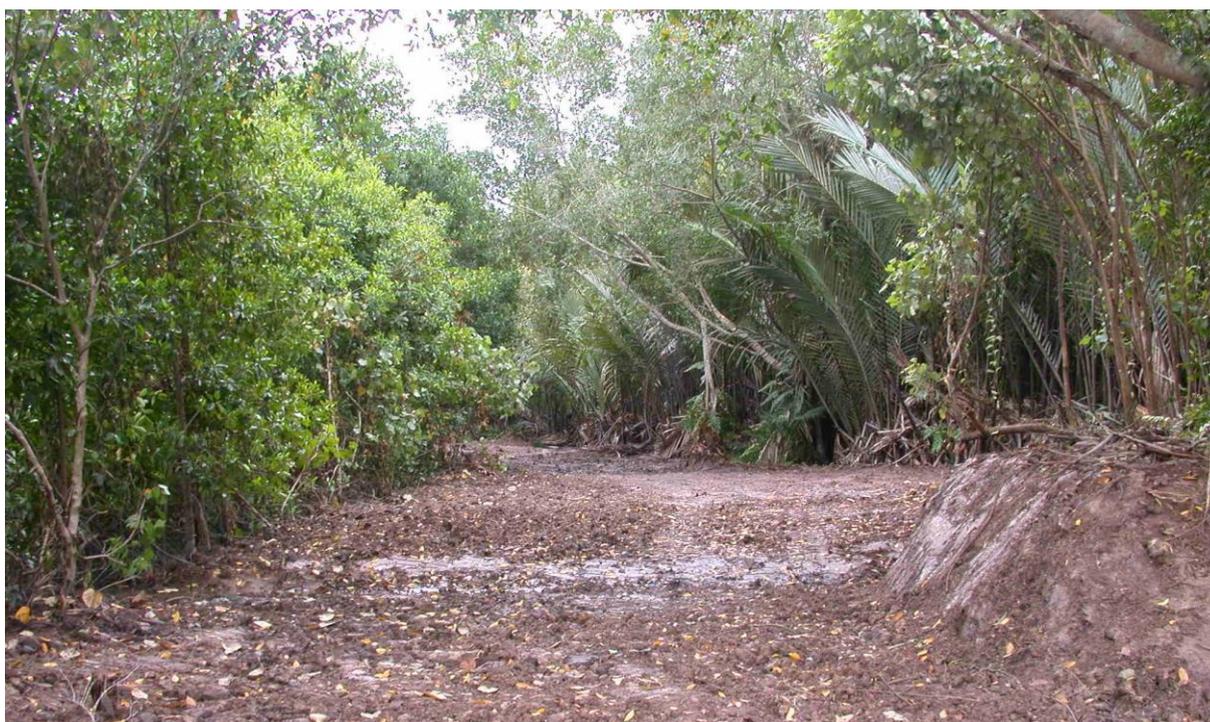
Fig. 4. Bunds around the pond were levelled down. Part of the bund yet to be cleared then can be seen on the right.

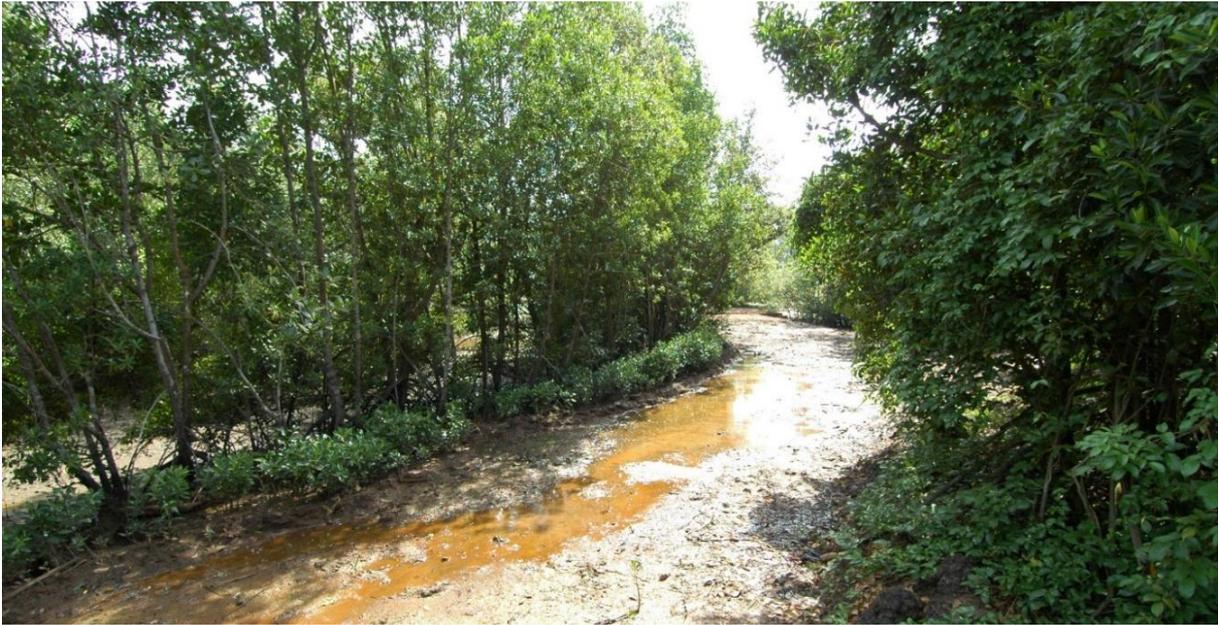
Fig. 5. The relevelled bunds facilitated natural mangrove colonisation.

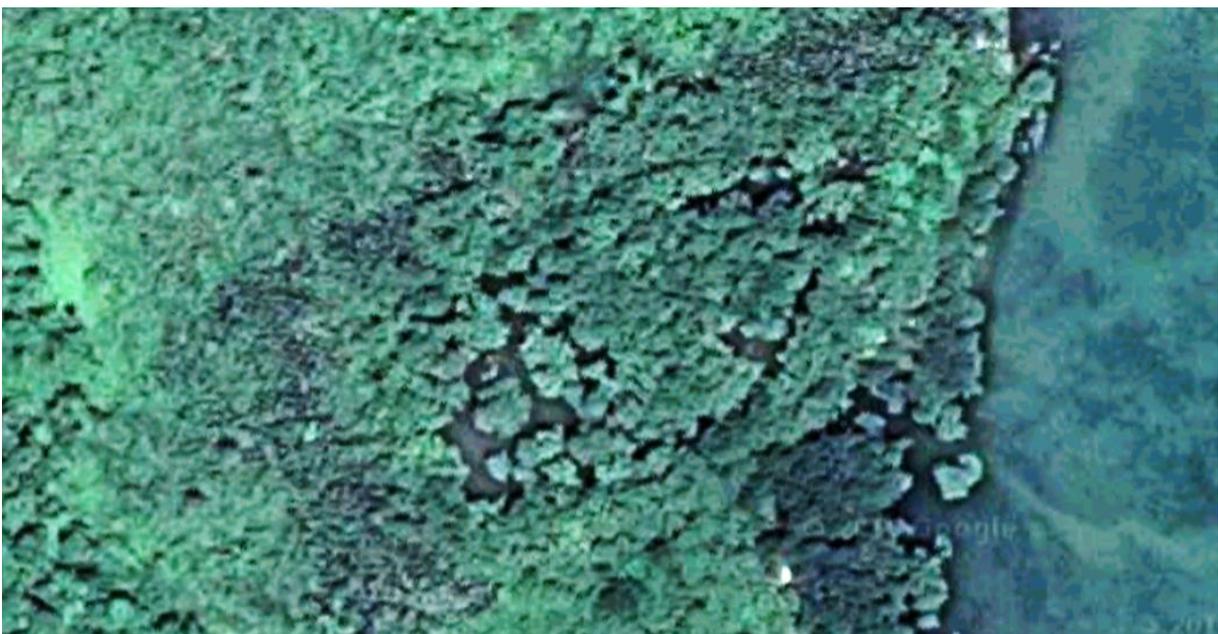
Fig. 6. Mangrove coverage of pond. (Image credit: Google Earth, 2017)

By 2017, mangrove vegetation had covered about 90% of the subject site (Fig. 6). Only the deepest areas of the pond where the elevations are lowest were not colonised by mangrove vegetation. Species that colonised the relevelled areas included *Acrostichum speciosum*, *Avicennia alba*, *A. officinalis*, *A. rumphiana*, *Brugueira cylindrica*, *B. gymnorhiza*, *Ceriops zippelliana*, *Excoecaria agallocha*, *Heritiera littoralis*, *Nypa fruitcans*, *Rhizophora apiculata*, *R. mucronata*, *Sonneratia alba*, *S. ovata*, *Scyphiphora hydrophyllacea*, *Hibiscus tiliaceus*, *Thespesia polpunea*, *Xylocarpus granatum*, and *X. moluccensis*.
