This paper looks at one mangrove restoration project on Pulau Ubin.

Mangrove restoration at Chek Jawa Wetlands

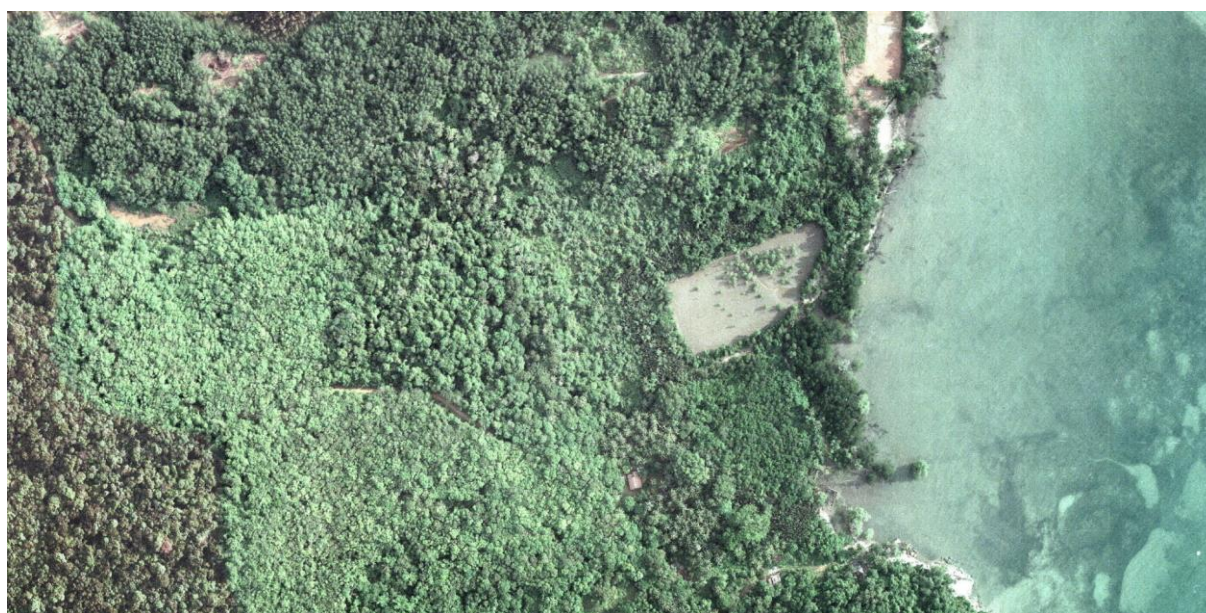
Fig. 2. Aerial photograph showing mangrove area at Chek Jawa Wetlands in 2001.

The project at Chek Jawa Wetlands centred on an abandoned prawn farming pond covering about 2 hectares, within a 6-hectare mangrove forest area (Fig. 2). Based on aerial photographs from the Ministry of Defence, the pond was in operation from at least 1969 to 1999. The prawn farming utilised local traditional farming methods, comprising a pond surrounded by mud bunds, with a sluice gate to control tidal inundation. The bunds were likely formed from mud excavated to create the pond and consisted of fine clay with remnants of mangrove mollusc shells.

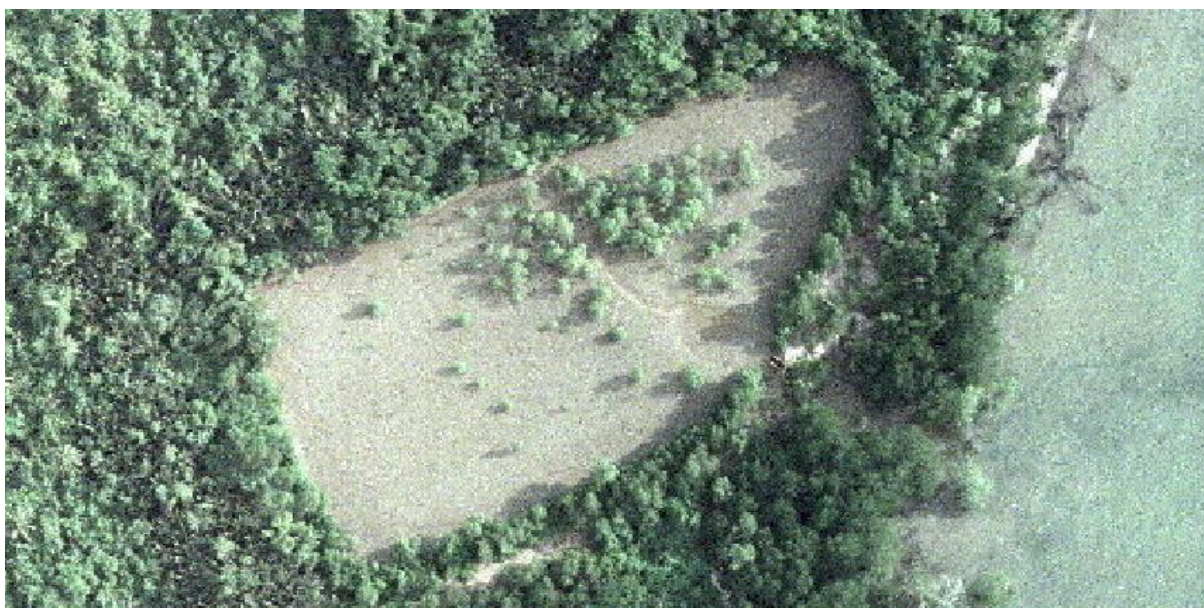
Fig. 3. Aerial photograph showing close-up of abandoned pond in 2001.

With the cessation of prawn farming operations, mangroves started to colonise naturally in shallower areas of the pond by 2001 (Fig. 3). A project to expedite the natural colonisation of mangroves commenced in 2005. Alien invasive plant species (e.g., *Acacia auriculiformis* and *Falcataria falcata*) which had established around the abandoned pond were removed, and the bunds were levelled down (Fig. 4 & 5) to allow inundation during high tides and exposure as the tides recede. The excavated materials were used to fill in the sides of the pond to raise the bottom of the pond in those areas. The restoration efforts facilitated the natural dispersal and establishment of mangrove seedlings in the relevelled areas – along the former bunds and the sides of the pond.

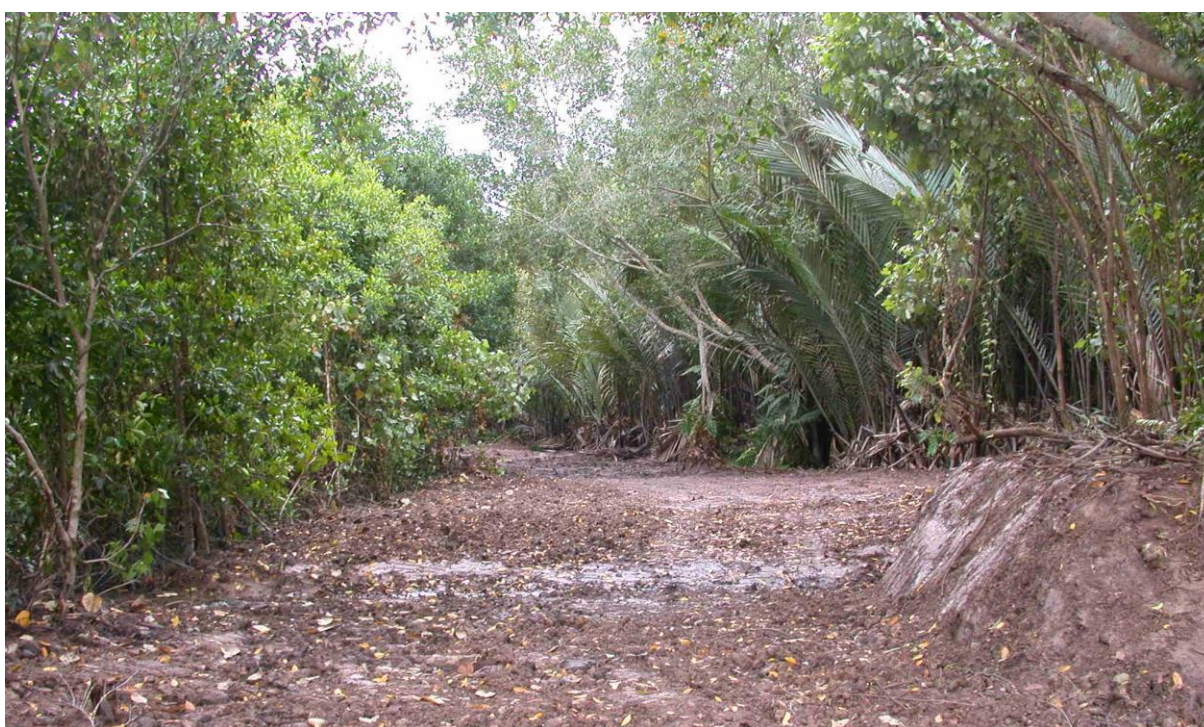
Fig. 4. Bunds around the pond were levelled down. Part of the bund yet to be cleared then can be seen on the right.

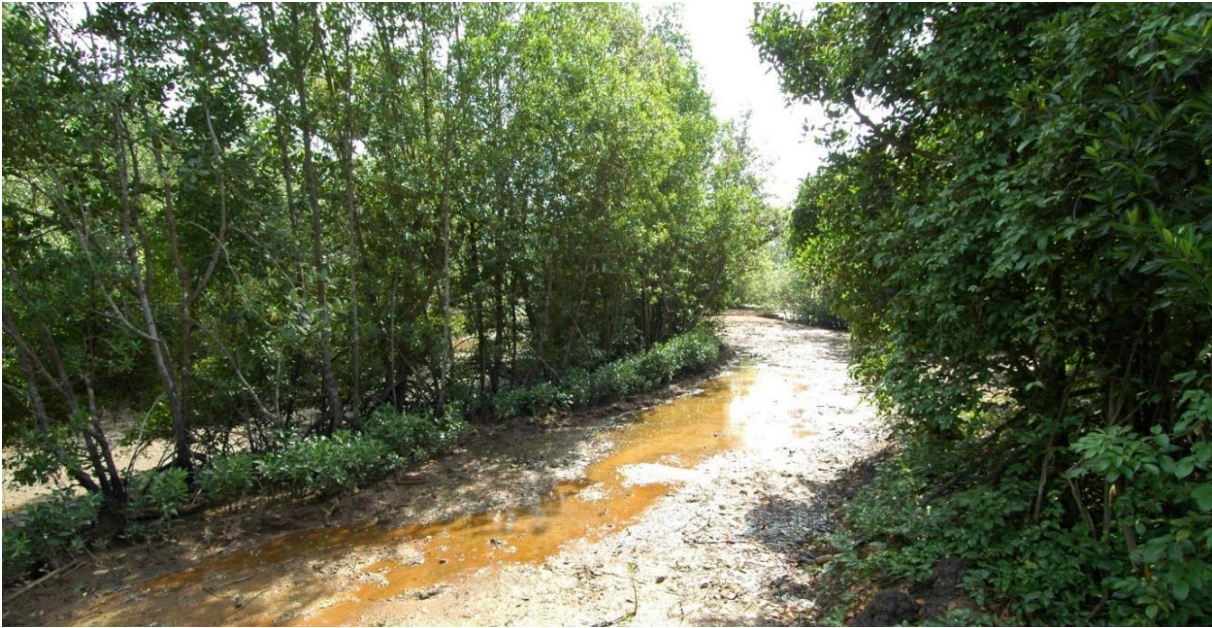
Fig. 5. The relevelled bunds facilitated natural mangrove colonisation.

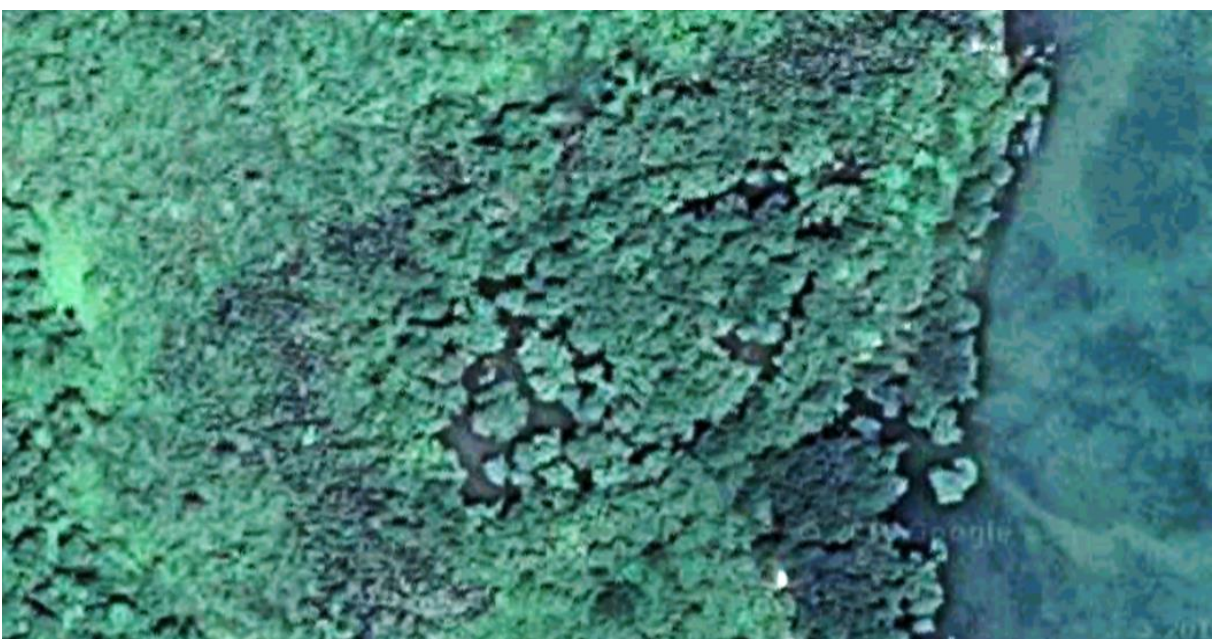
Fig. 6. Mangrove coverage of pond. (Image credit: Google Earth, 2017)

By 2017, mangrove vegetation had covered about 90% of the subject site (Fig. 6). Only the deepest areas of the pond where the elevations are lowest were not colonised by mangrove vegetation. Species that colonised the relevelled areas included *Acrostichum speciosum*, *Avicennia alba*, *A. officinalis*, *A. rumphiana*, *Brugueira cylindrica*, *B. gymnorhiza*, *Ceriops zippelliana*, *Excoecaria agallocha*, *Heritiera littoralis*, *Nypa fruitcans*, *Rhizophora apiculata*, *R. mucronata*, *Sonneratia alba*, *S. ovata*, *Scyphiphora hydrophyllacea*, *Hibiscus tiliaceus*, *Thespesia polpunea*, *Xylocarpus granatum*, and *X. moluccensis*.
